Fairmaid Builders Ltd in conjunction with Jeff Evans Ltd

Mountain Jade Building General Report

Mountain Jade Building, Roof and outside cladding etc. General report

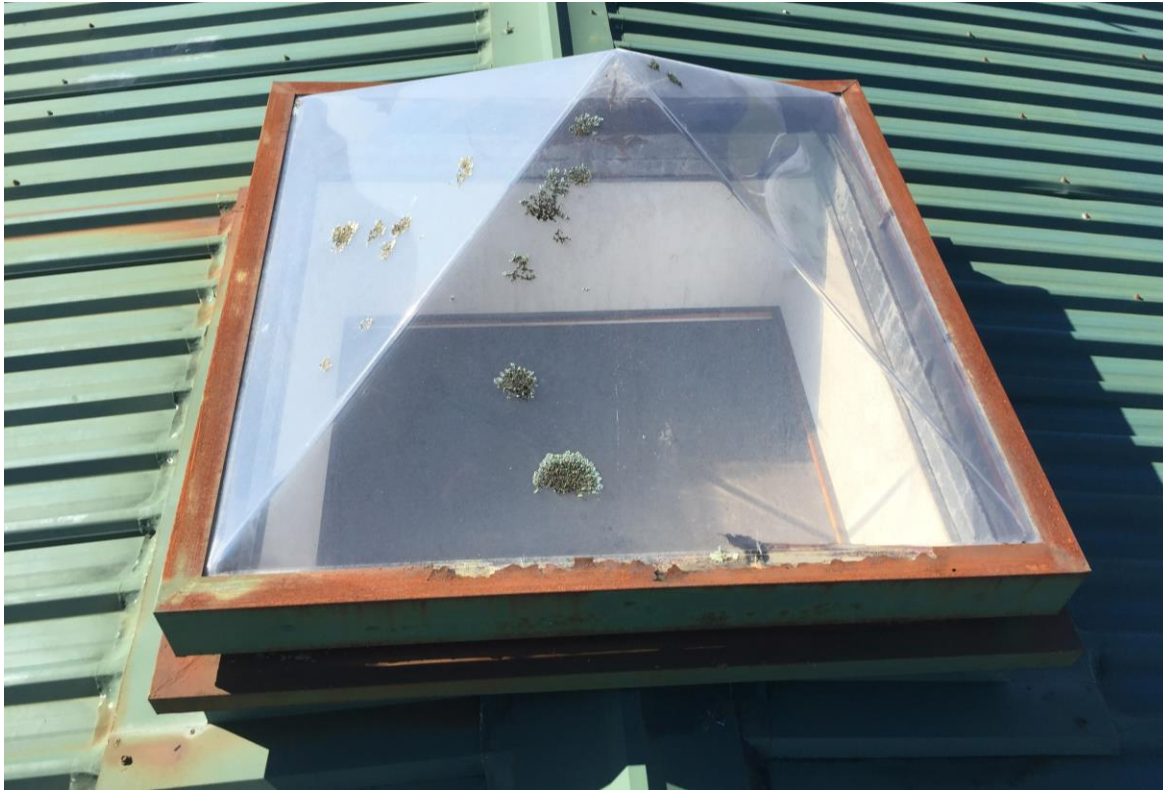
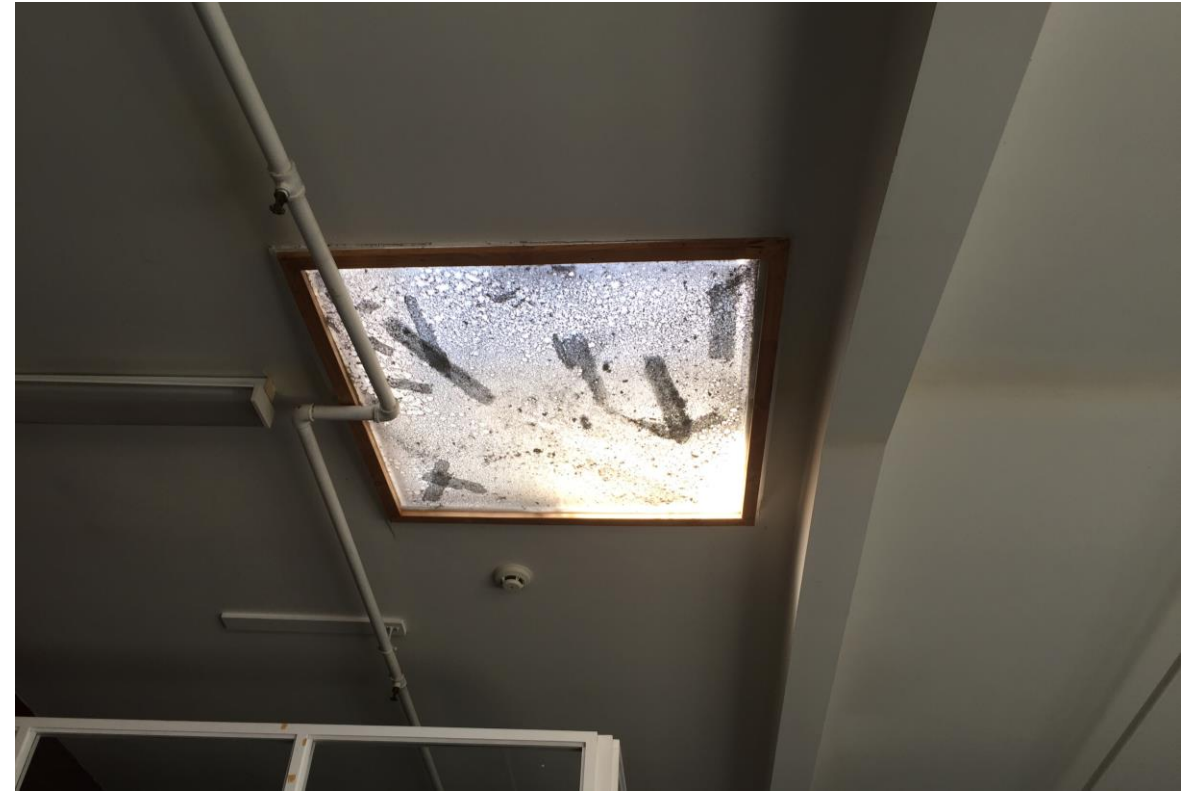
SKYLIGHTS OVER EASTERN AREA

- The area of most concern to us is the skylights. These were not weather proofed well, so the flashing will need replacing.
- The skylights themselves would appear to be not leaking but their value in useable light to us is questionable. They are very dirty and letting in very little light as can be seen in the above photo. It's of the authors opinion that these should be removed all together.
- There is also an area on the southern end of this building where the iron has been joined and has now rusted through. The leak that is showing on the ceiling in the gym area is probably caused by this.

- It is also in our opinion that most, if not all the skylights could be done away with, as they are currently letting in very little light and if it was decided that some were still required there are far better and more efficient skylights available today. The main concern is that the flashing detail on the existing ones is a problem area

- The flashings have been very susceptible to rust and you can see that in two of the photos, our advice would be to do away with the skylights all together and use modern day lighting as the light source. LED lighting today is a low cost and efficient way of providing light in a modern office type environment.

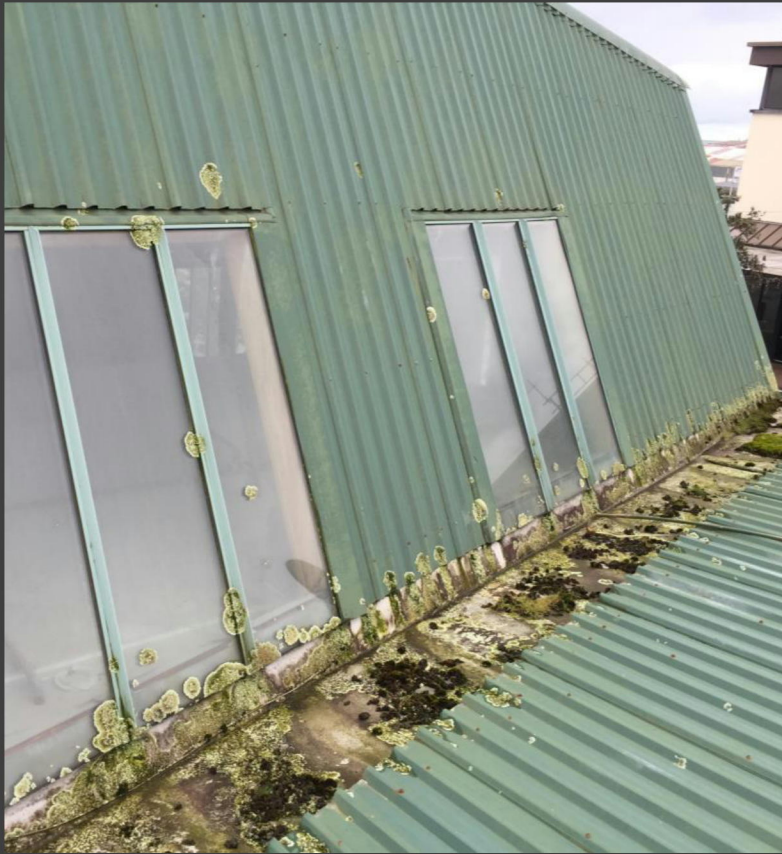
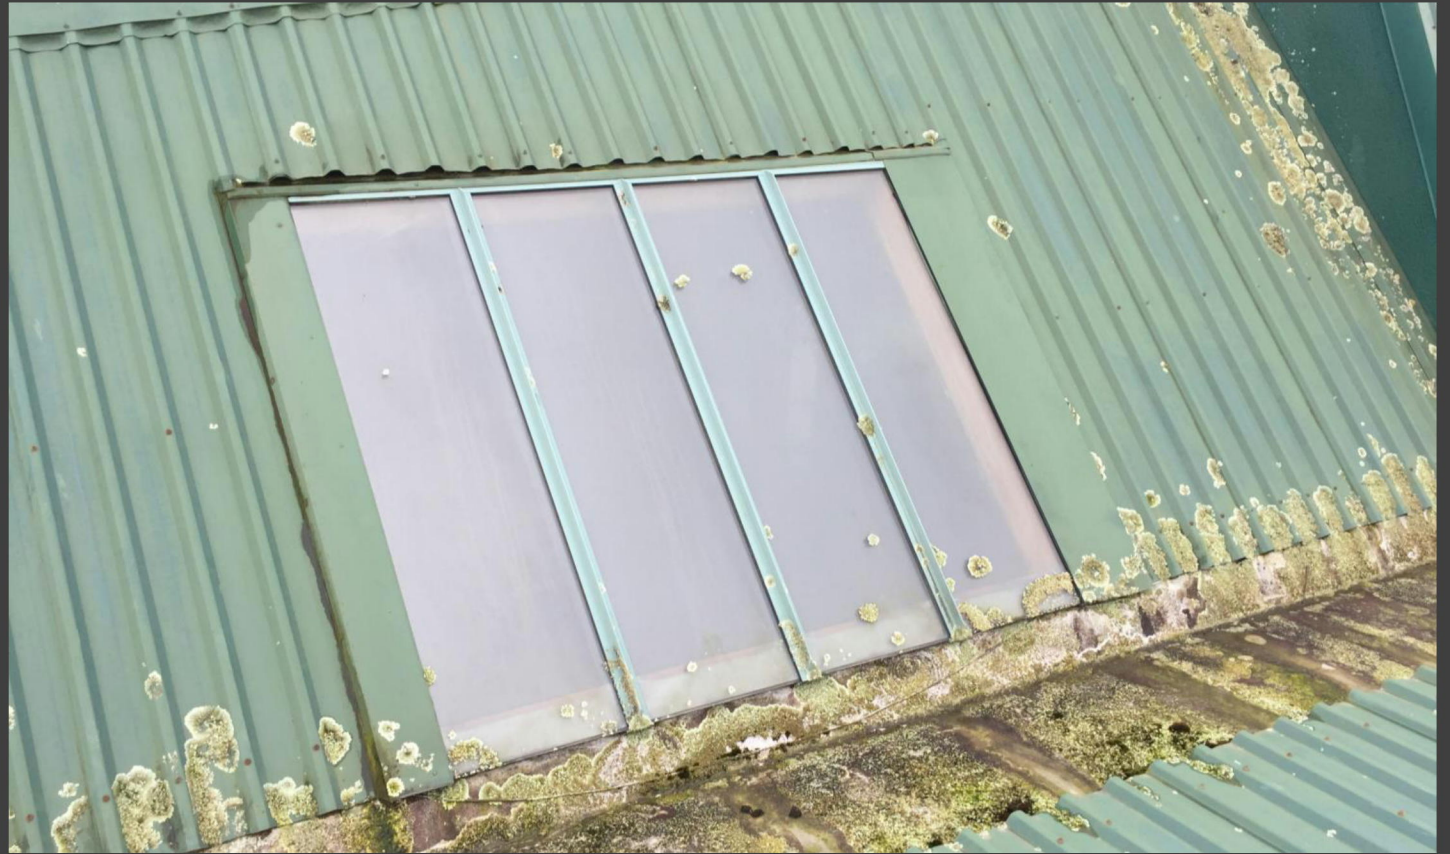
INTERNAL GUTTERS

- The areas that are showing obvious signs of leaking in the building are the opinion of the authors to be mainly from a leaking roof and guttering system [redacted] and doesn't stem from the break down of the cladding in any areas. While there could be water getting in from the break down of the cladding it is our opinion that it stems from a [redacted] and also most of the water damage that you can see from the footpath is from the gutters over flowing as the downpipes are not in a position to handle the West Coast heavy down pours. There is a huge roof area and the water is collected by quite large gutters up on the roof but a majority of the downpipes are far to small to handle the water that is expected to go down them.

- It should be noted that the gutters on the plans are shown to be lined with butynol but this was not done and it would appear that they have been lined with a fiberglass product which was used as a substitute to butynol at the time of building. To our knowledge this product is no longer used and most internal guttering systems are lined with butynol.

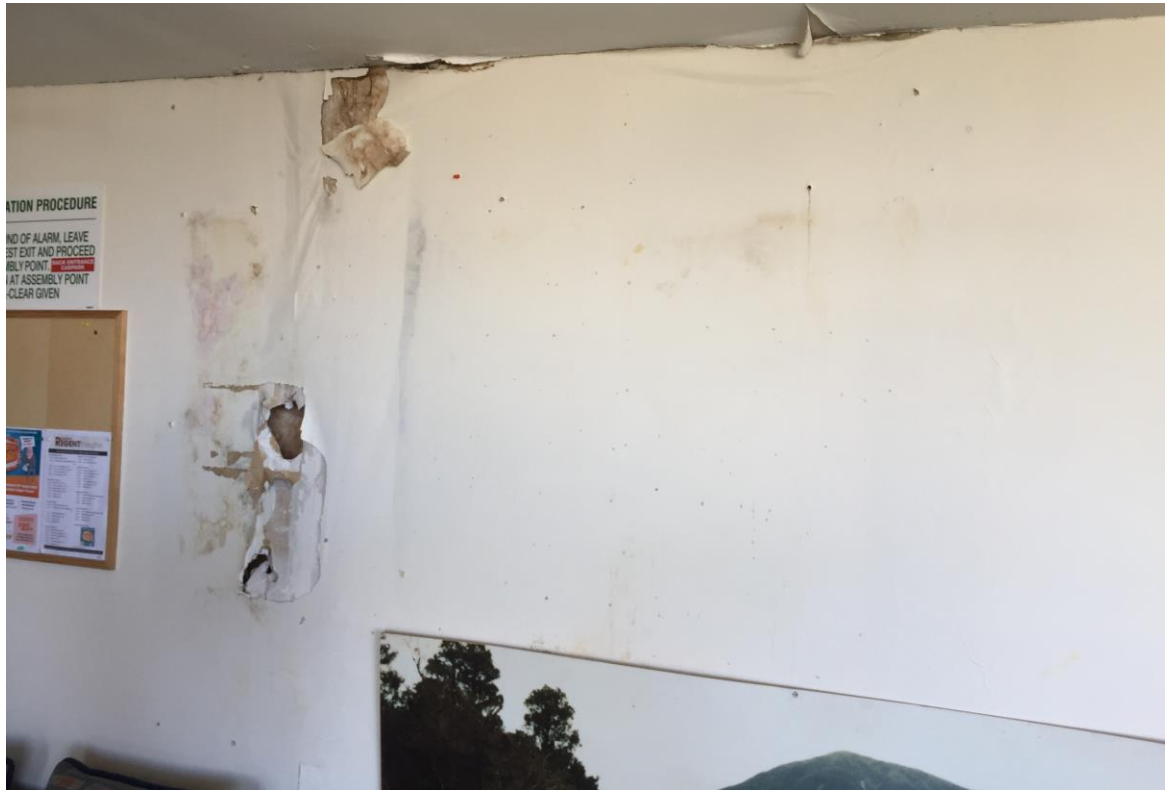
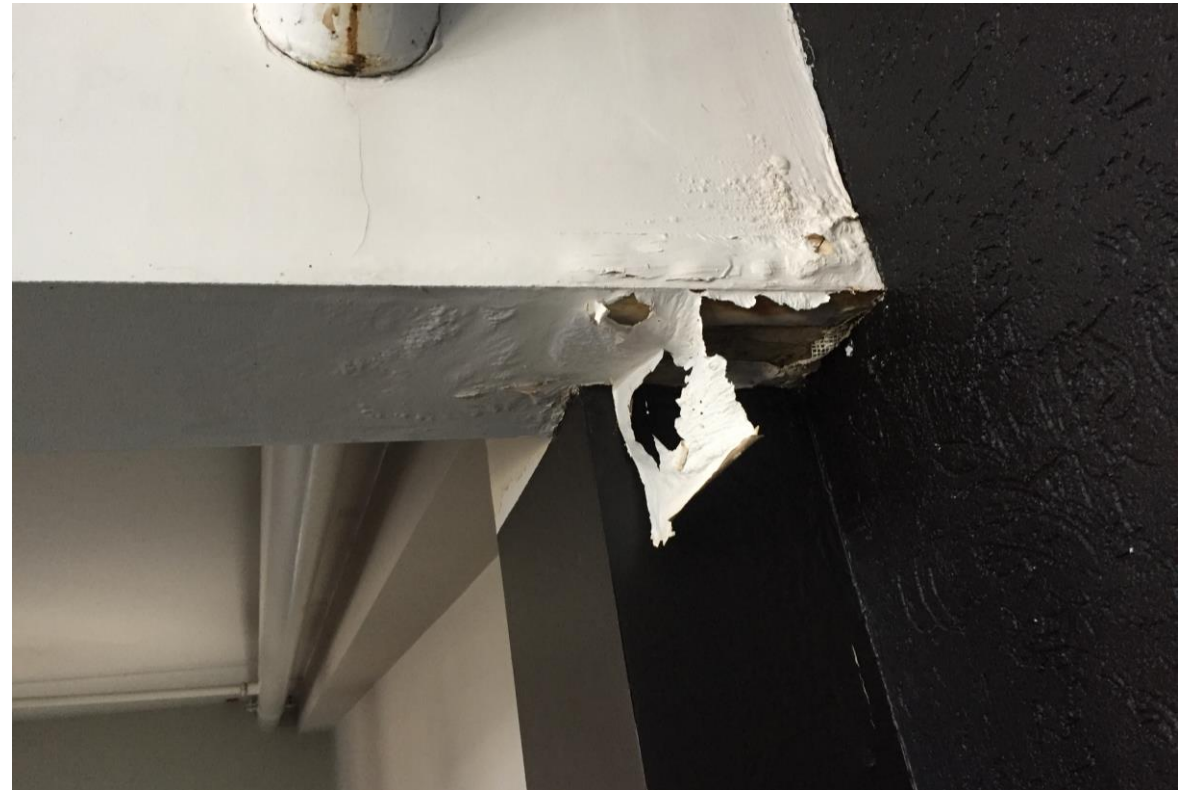
DAMAGE CAUSED BY GUTTERS OVER EASTERN AREA

- Images above highlight damage that will be repaired and will not happen again with new internal gutters.

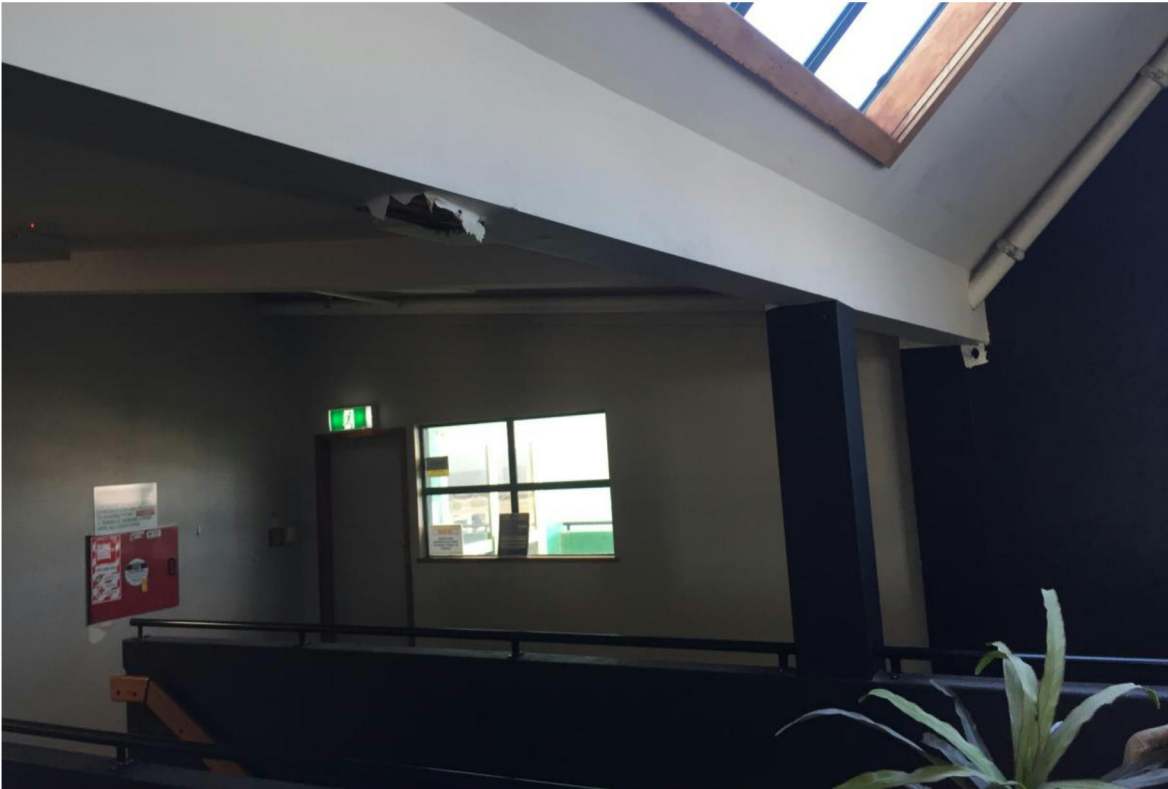
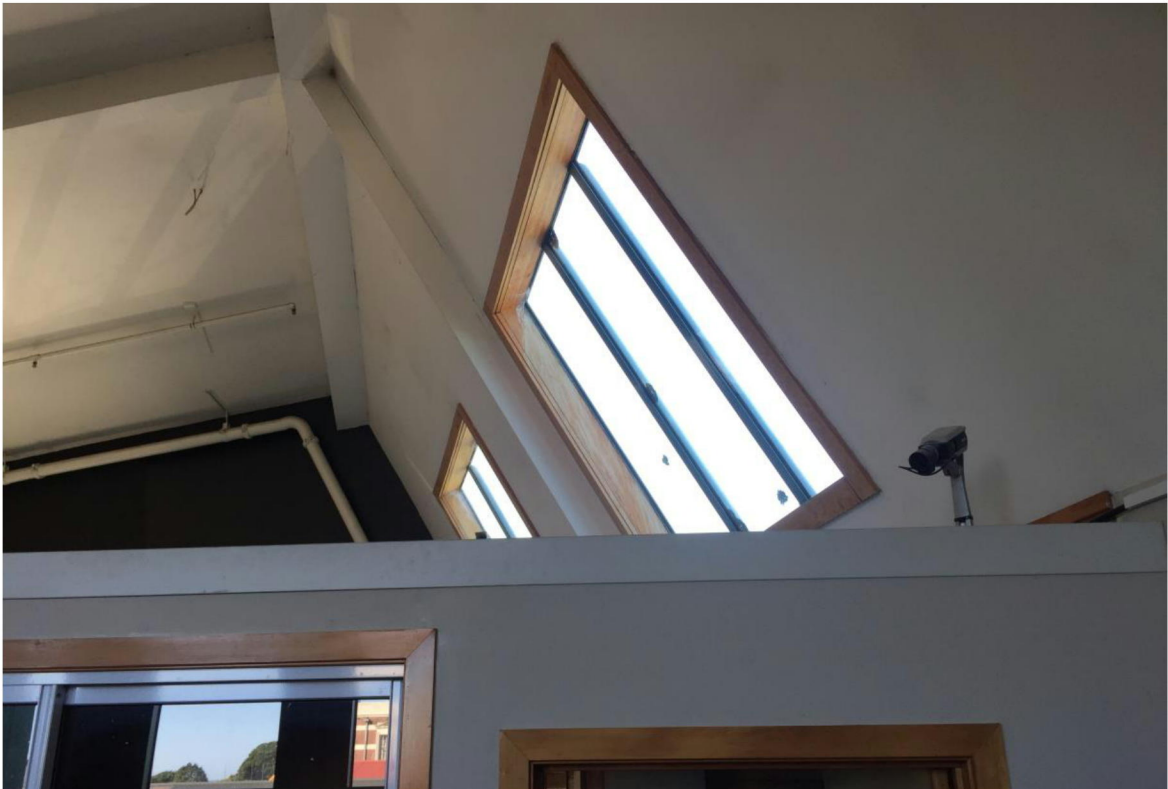
LEAK ON ROOF WINDOWS

- The above image highlights the damaged caused by the incorrect installment of a wall window, into the roof.

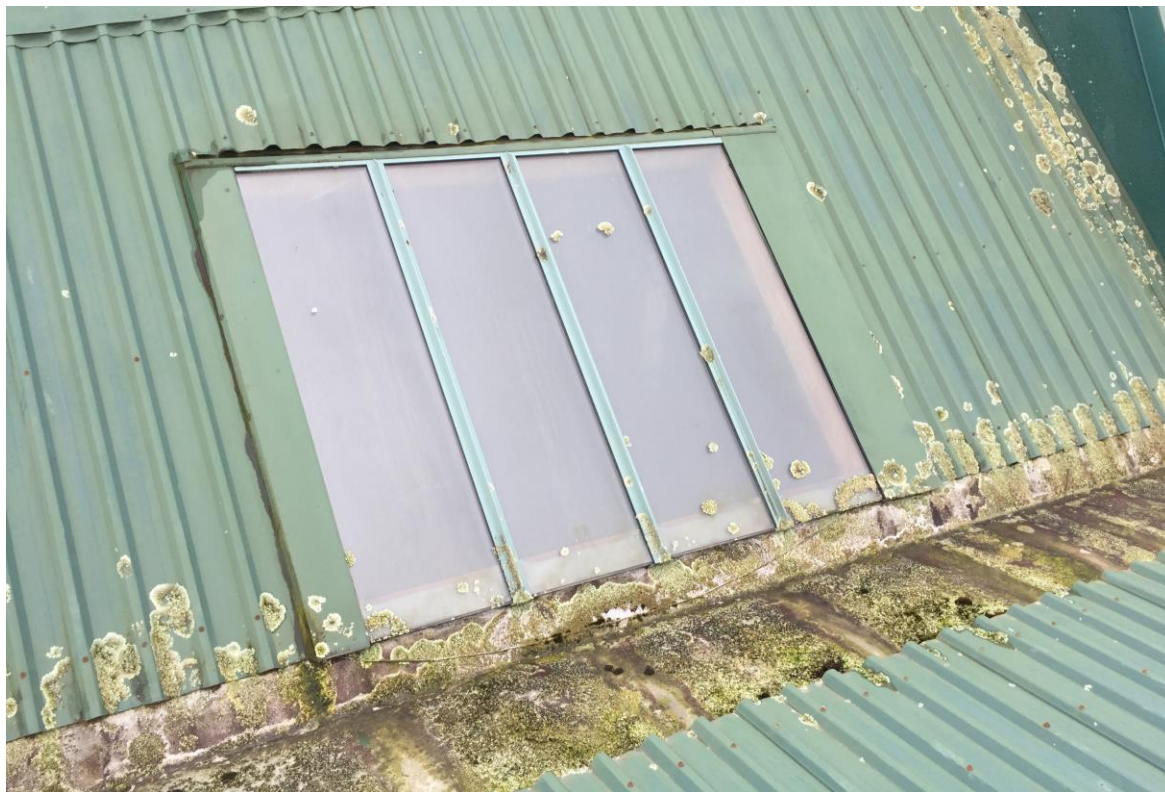
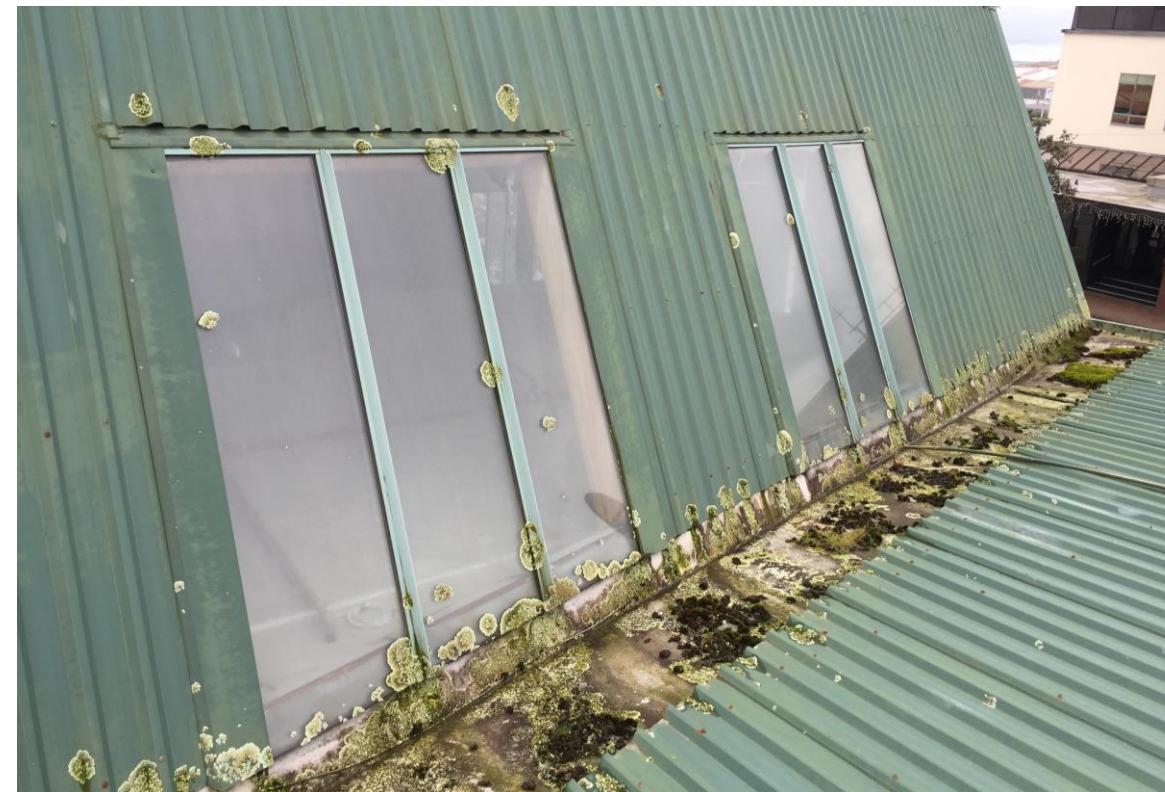
WINDOWS OVER EASTERN AREA

- There are some windows especially to the east, overlooking the eastern part of building, that are leaking and it would appear to be either a window problem or a flashing problem.
- Something that would need a more detailed look at, in our opinion, if these windows were actually installed in the right sort of detail, then they would be fit for purpose in this sort of installation.

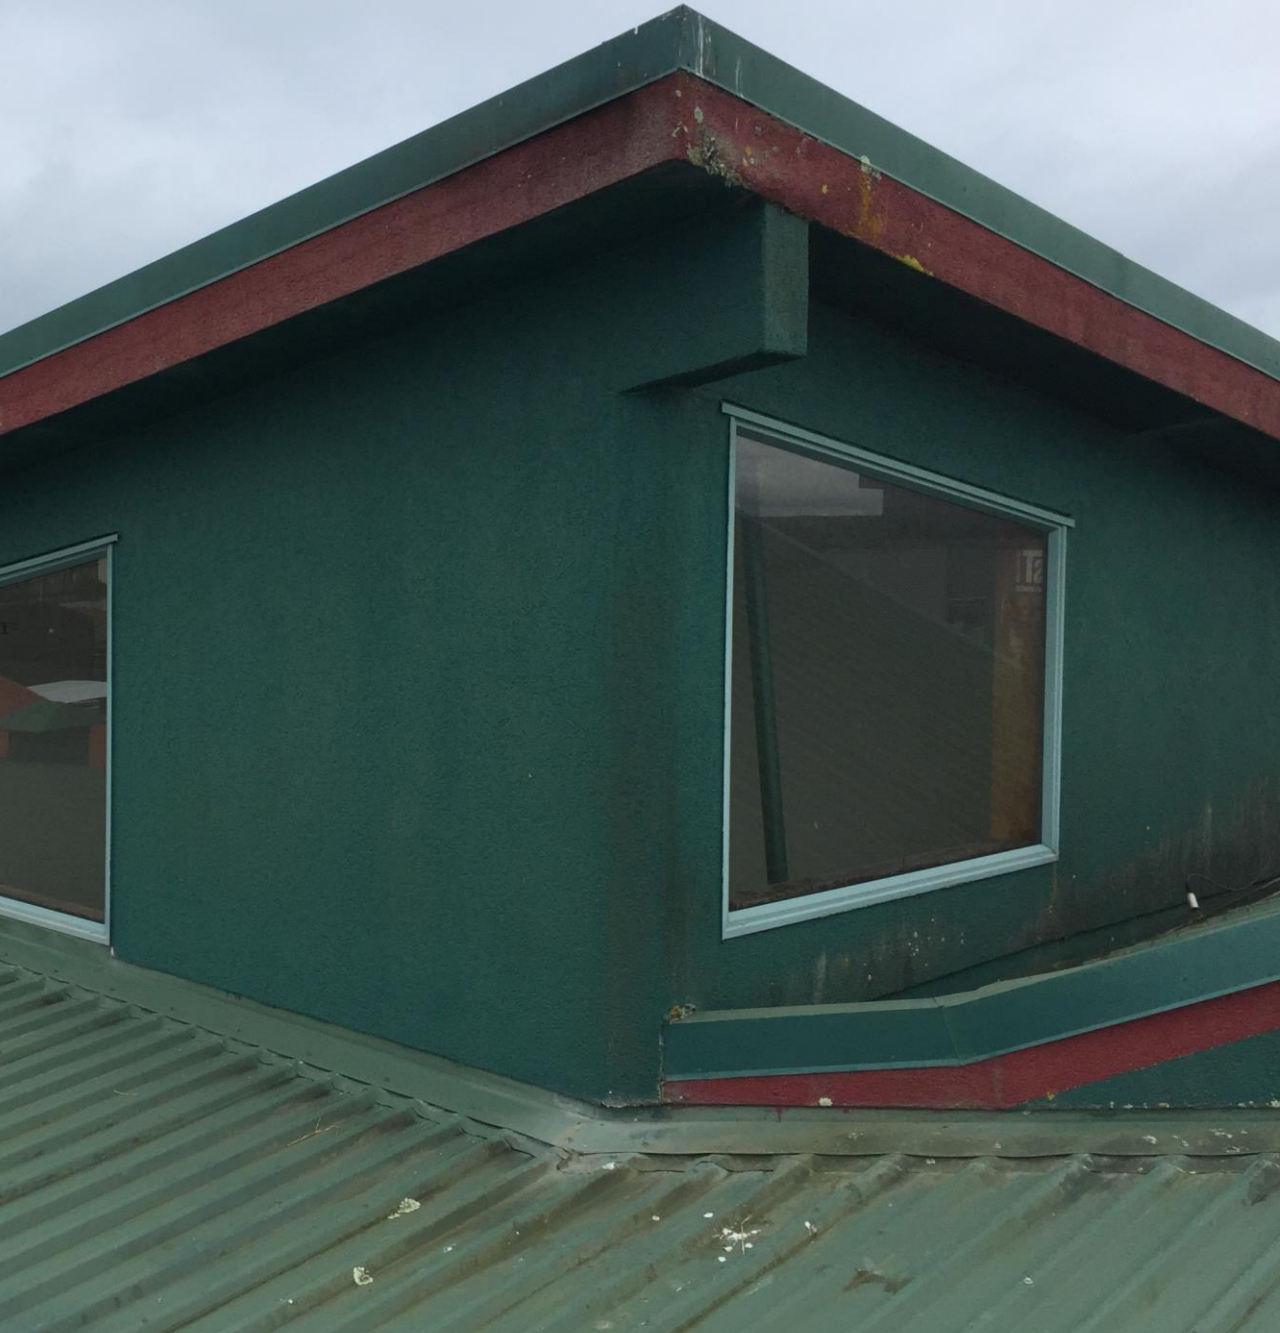
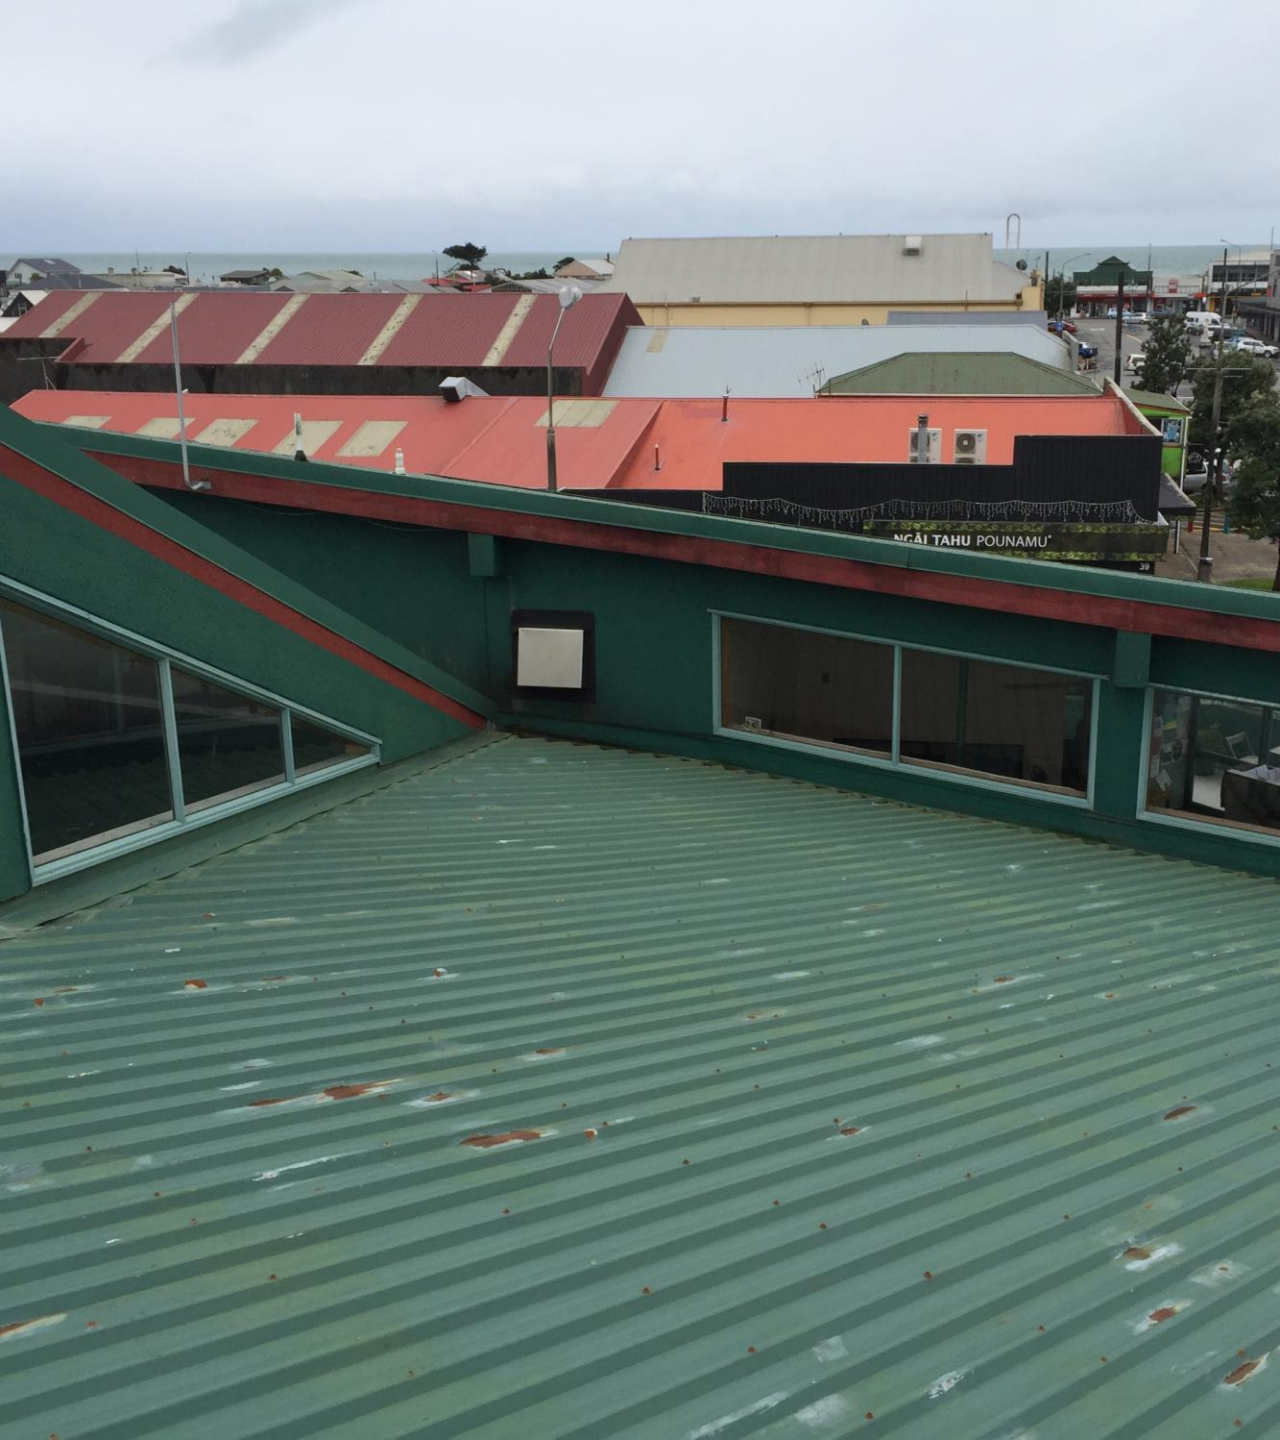
WALL FRAMES OVER EASTERN AREA

- We were unable to determine the condition of any wall framing but the lower area appeared okay. This is mainly concrete wall construction.
- Most of the windows appear to be in a reasonable condition, with not too many leaks.
- There are a few areas that will probably in time need addressing.
- Some cladding around the windows seem to not be in the best condition, although for a building cladded with a product like this (I presume it is a harditex) it is in good condition.
- The cladding does appear to be in a condition which shows no appearance of failing, but the plaster finish in areas could do with reinstating.

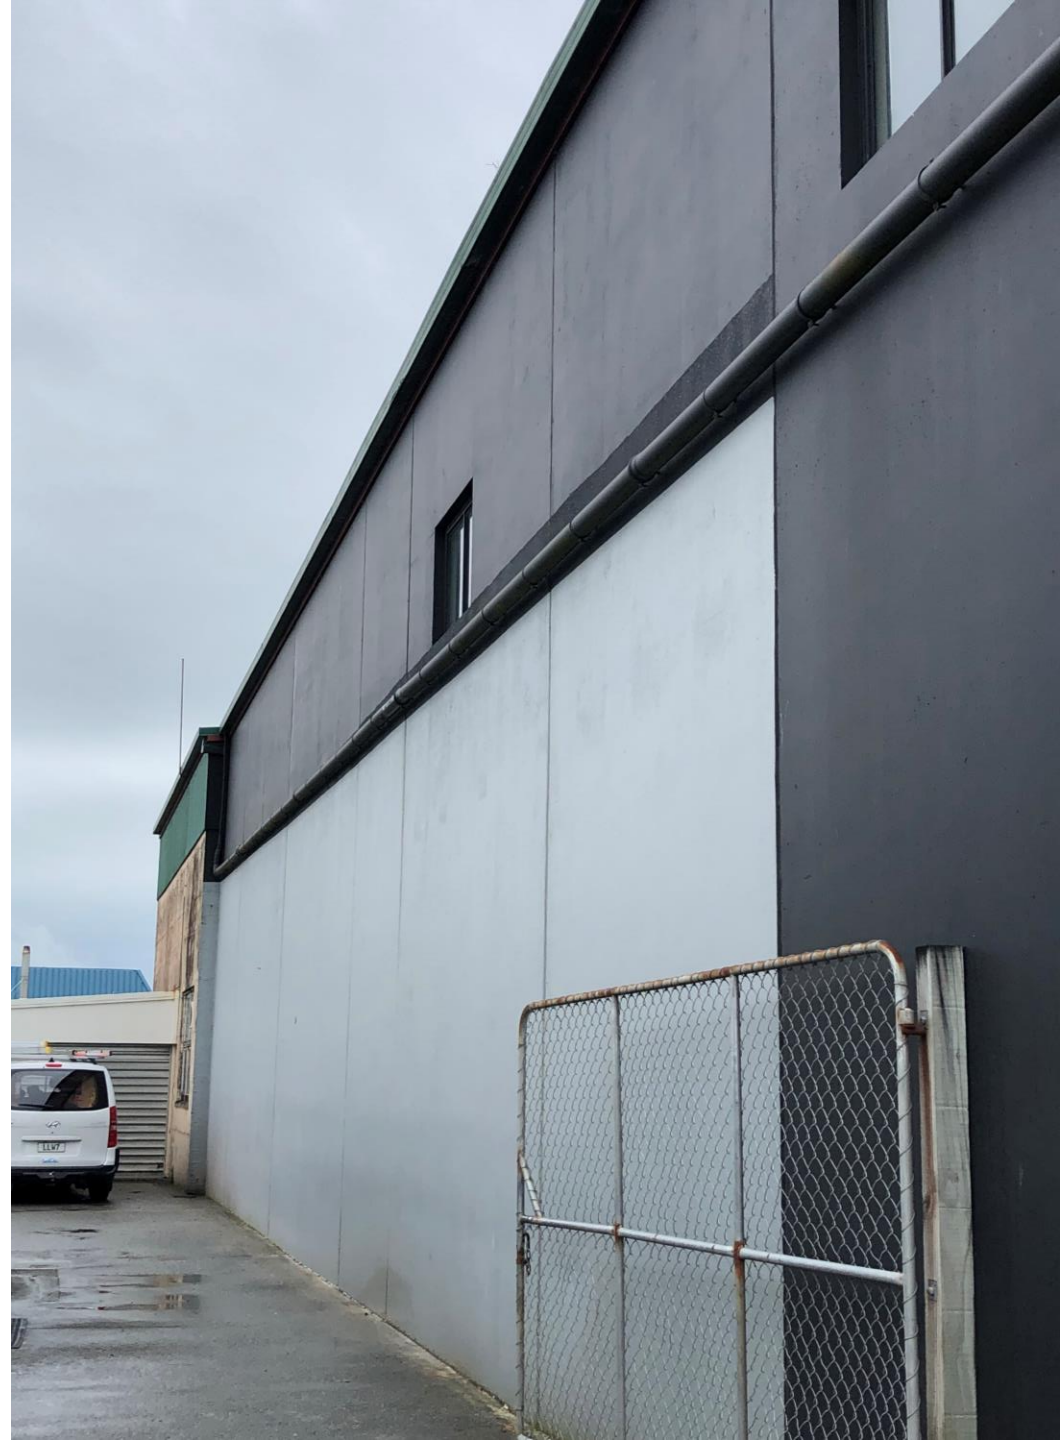
EAST FACING WALL, WELD STREET

- The photo highlights the small area above the foot path on Weld street. This is only a small area and there is a breakdown in the cladding, due to the current plastering and paint system.

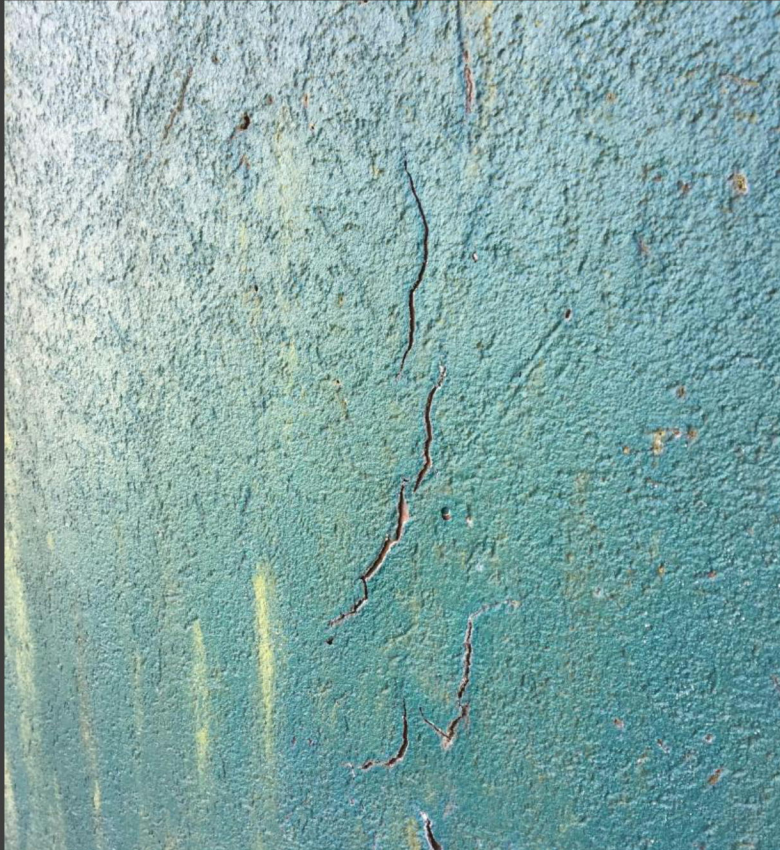
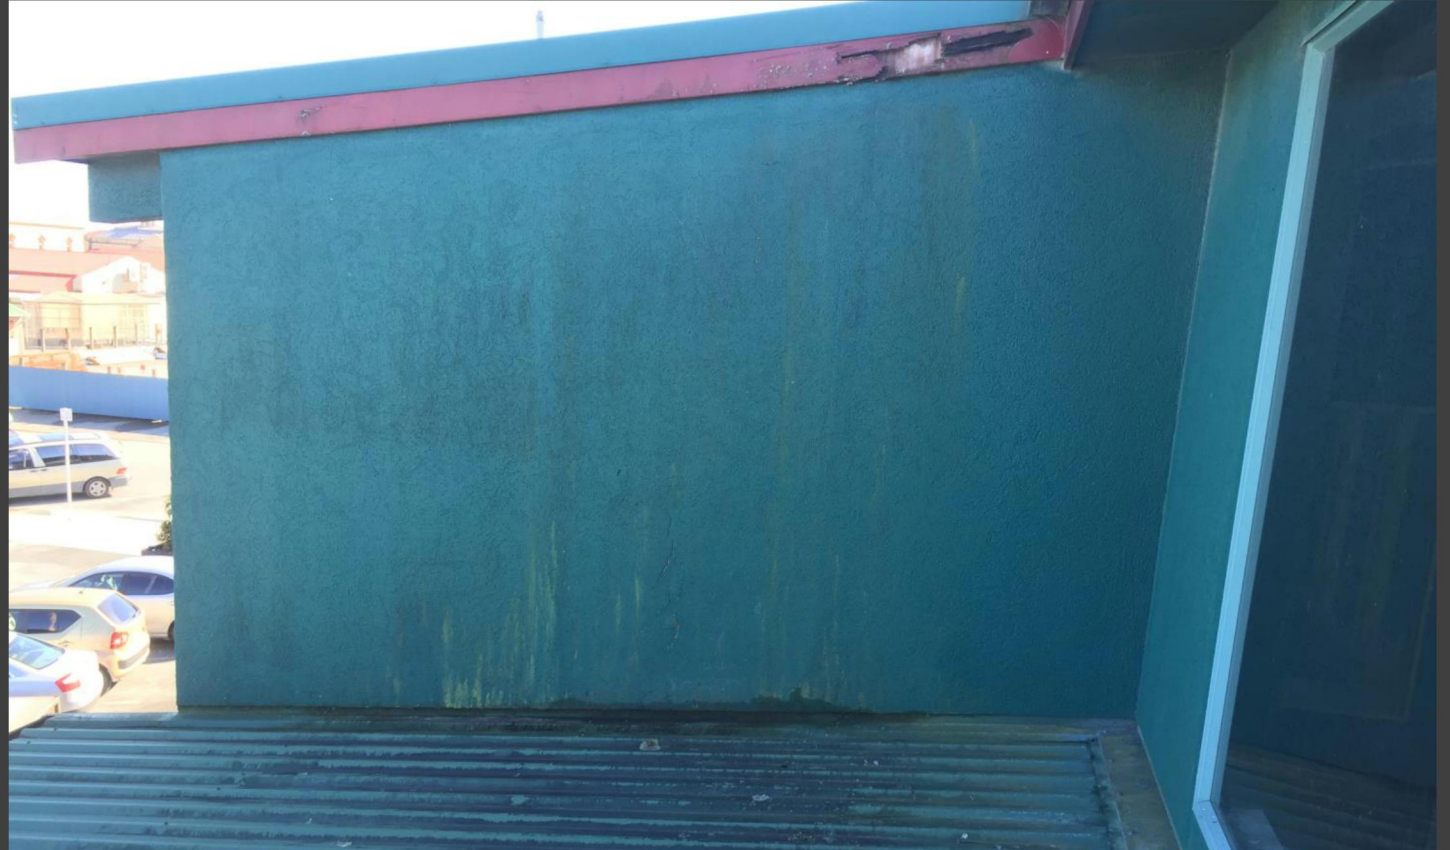
SOUTH EAST WALL OVER-LOOKING CARPARK

- There are at least three areas that will in my opinion need to be replaced, one is a back wall at right angles to the back car park this area which doesn't get any sun so the cladding over time has deteriorated and the plaster coating is coming away from the base material, this area would need to be reclad and a new cladding put on, my thought is Monotek sheet over a cavity system and then replastered and painted. It is worthy to note that considering the age of the cladding it is in very good condition.

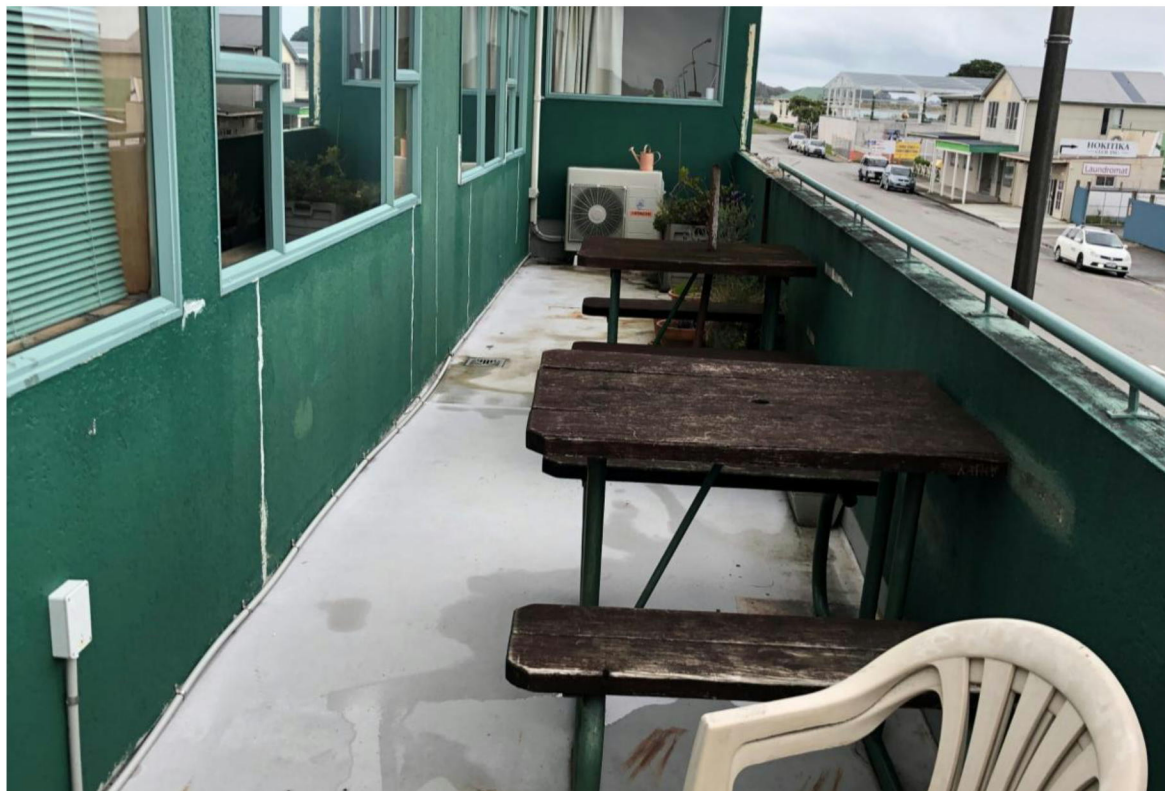
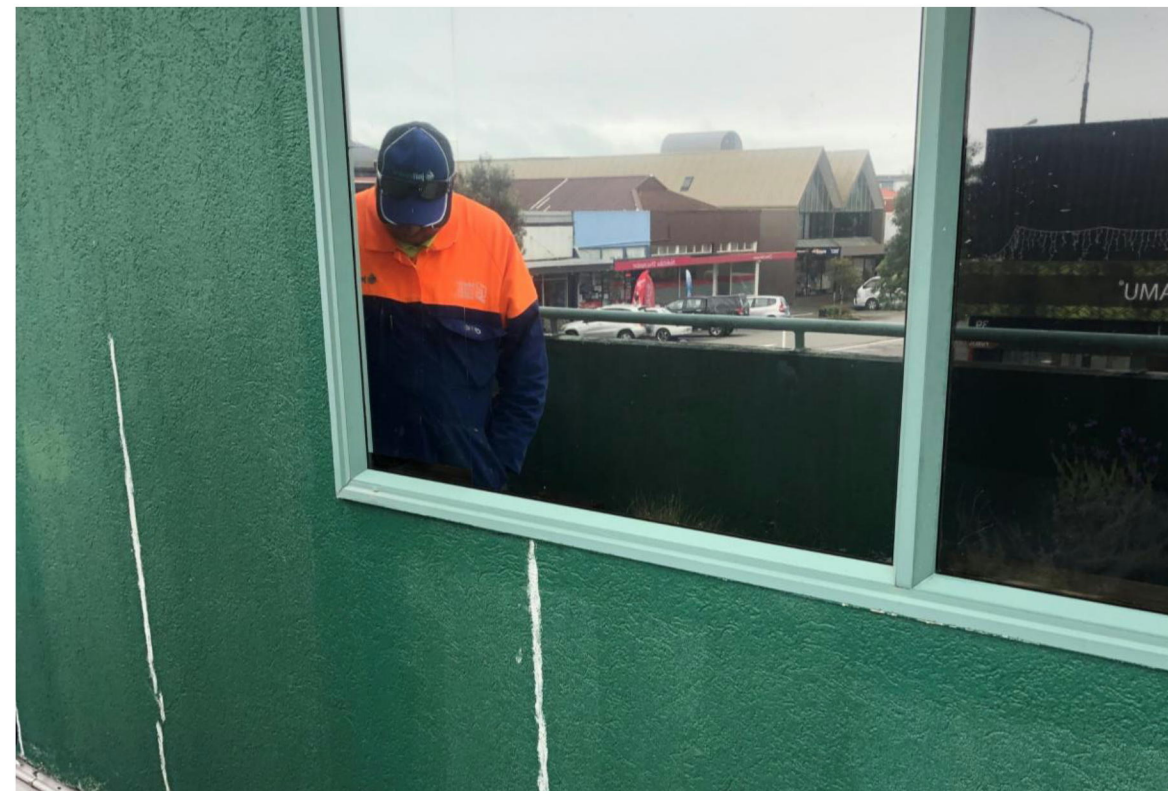
VERANDA'S OVER SEWELL STREET

- Another area is the wall above the deck over Sewell Street and also the balustrade which would appear to have a water penetration problem, while there are other balustrade areas this would appear to be the only one with issues but an invasive check may prove otherwise, the wall in this area has obvious signs of deterioration and would need rebuilding, again this could be achieved by once again using the flat sheet and cavity system and also replastering and painting.
- These observations are taken without being able to view inside the wall but I have made an allowance for the replacement of some of the timber framing but not all of it.

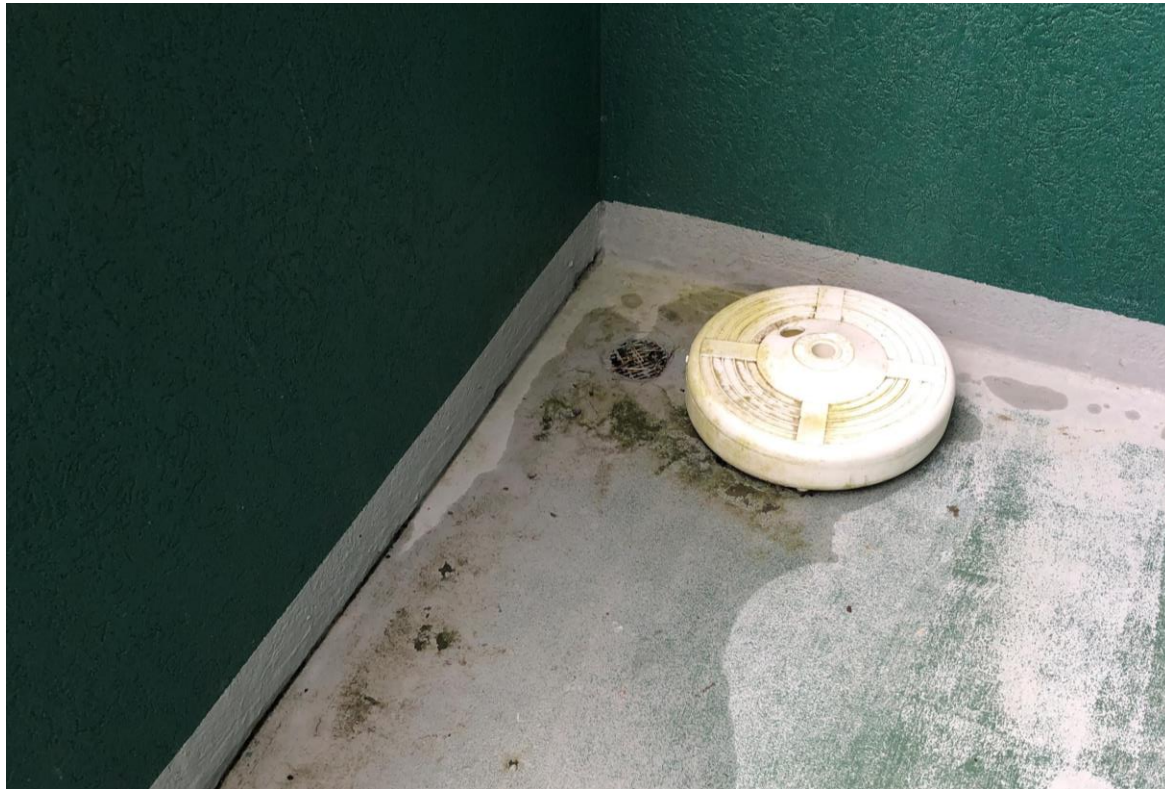
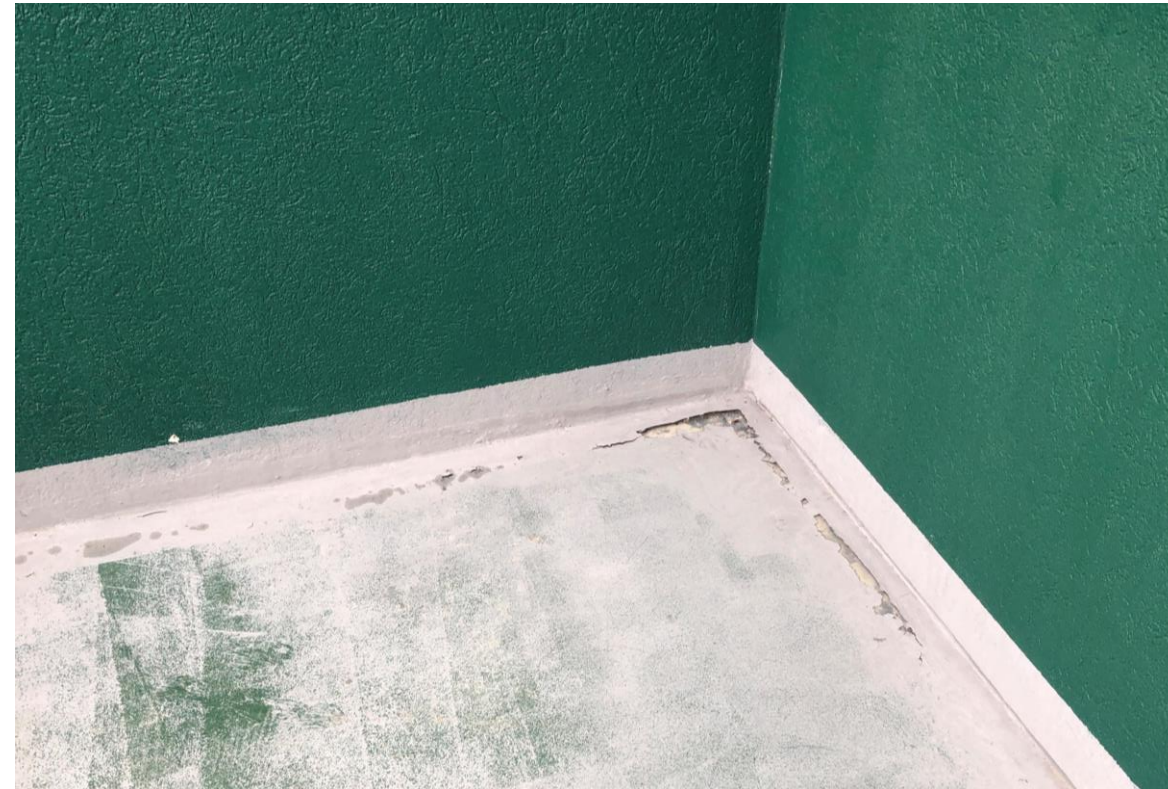
VERANDA'S OVER WELD STREET

- The veranda areas that run along the street we have not had a detailed look at but again these areas will probably need some attention as there are obvious signs that there are leaks there. Whether this is caused by the guttering or the roofing we are not sure.
- The building downpipe system which was probably in keeping with the design of the building. Some of the internal downpipe systems may need changing, again something that needs to be looked at in more detail.
- Please see crack in corner of porch, fiber glass has lifted.
