Fairmaid Builders Ltd in conjunction with Jeff Evans Ltd

Mountain Jade Building General Report

Mountain Jade Building, Roof and outside cladding etc. General report

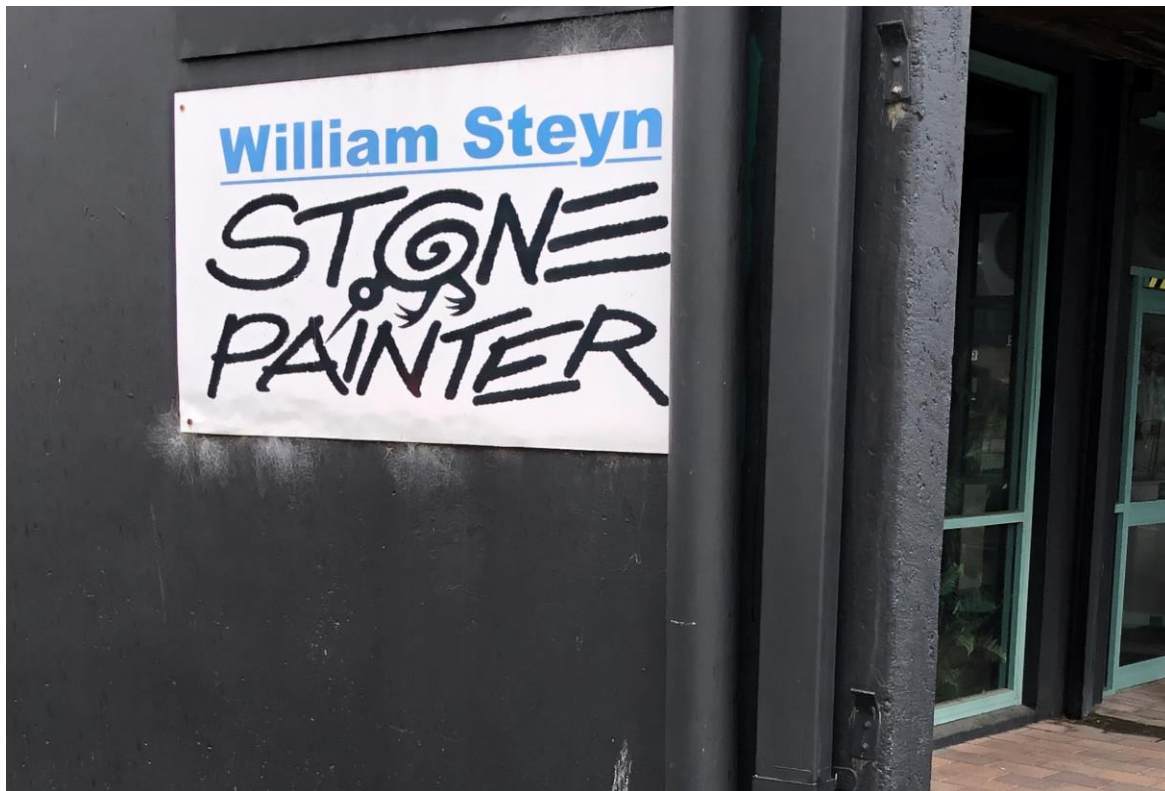
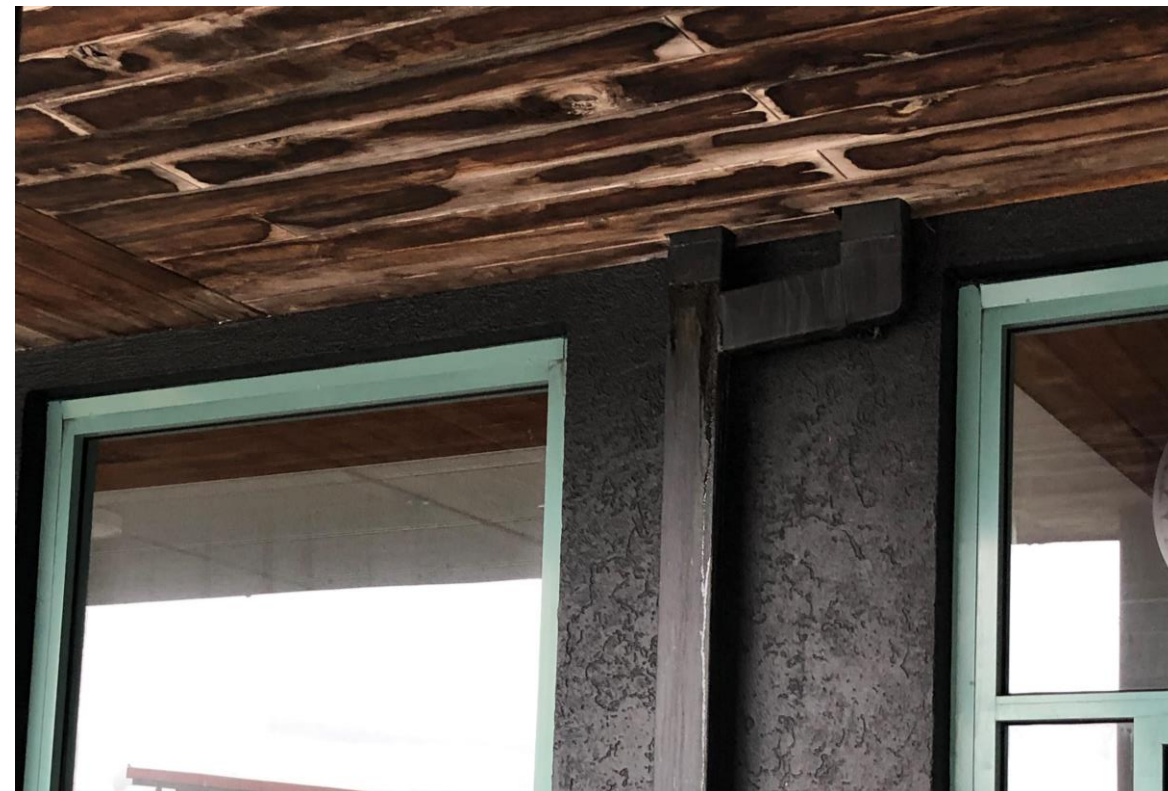
DOWNPIPES OVER EASTERN AREA

- There are leaks in other areas but some of them are coming from the downpipe systems, and probably not directly related to the actual roof.
- Some flashing details are not quite the best.
- As you can see in the photos there are some areas that look quite bad. Although we have not done an invasive search.

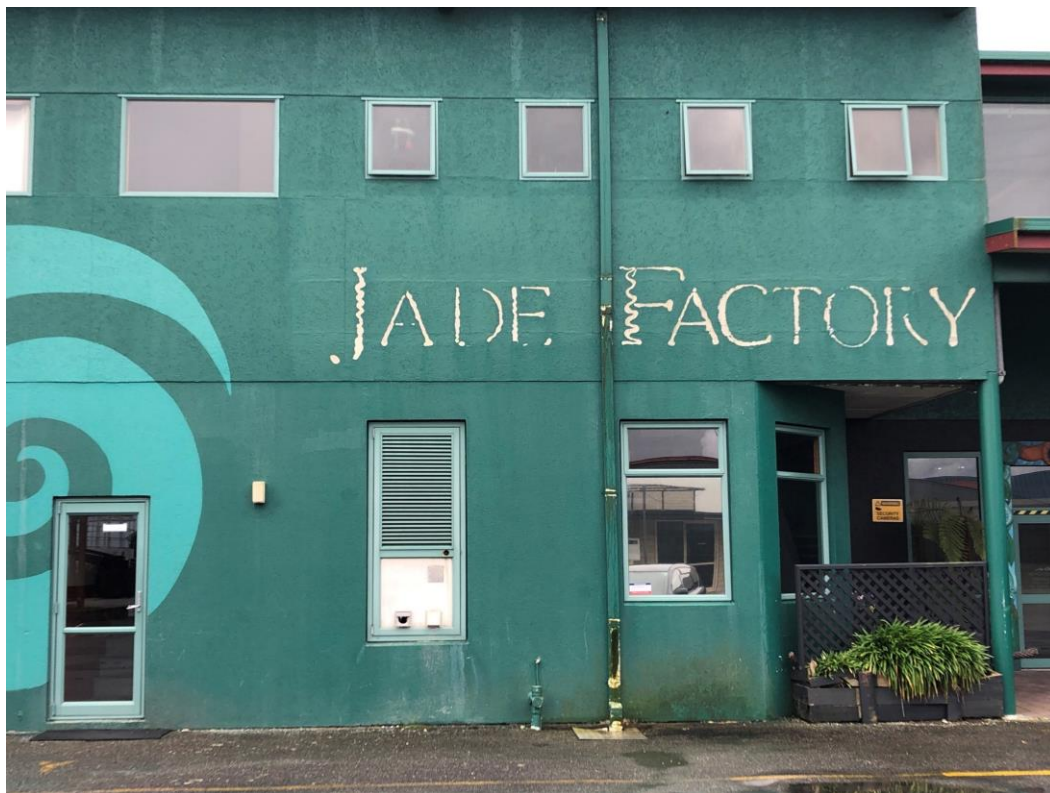
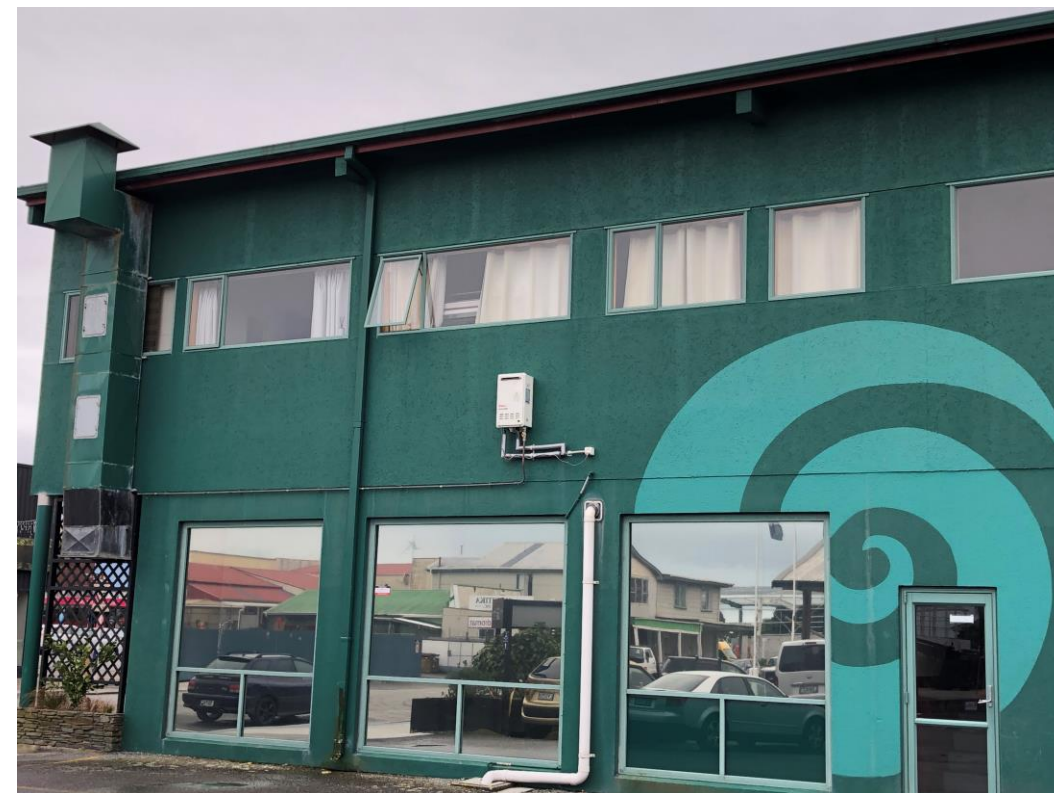
SOUTH FACING WALL

- Above images highlight the South facing wall, this wall will need to be re plastered and painted due to lack of maintenance.

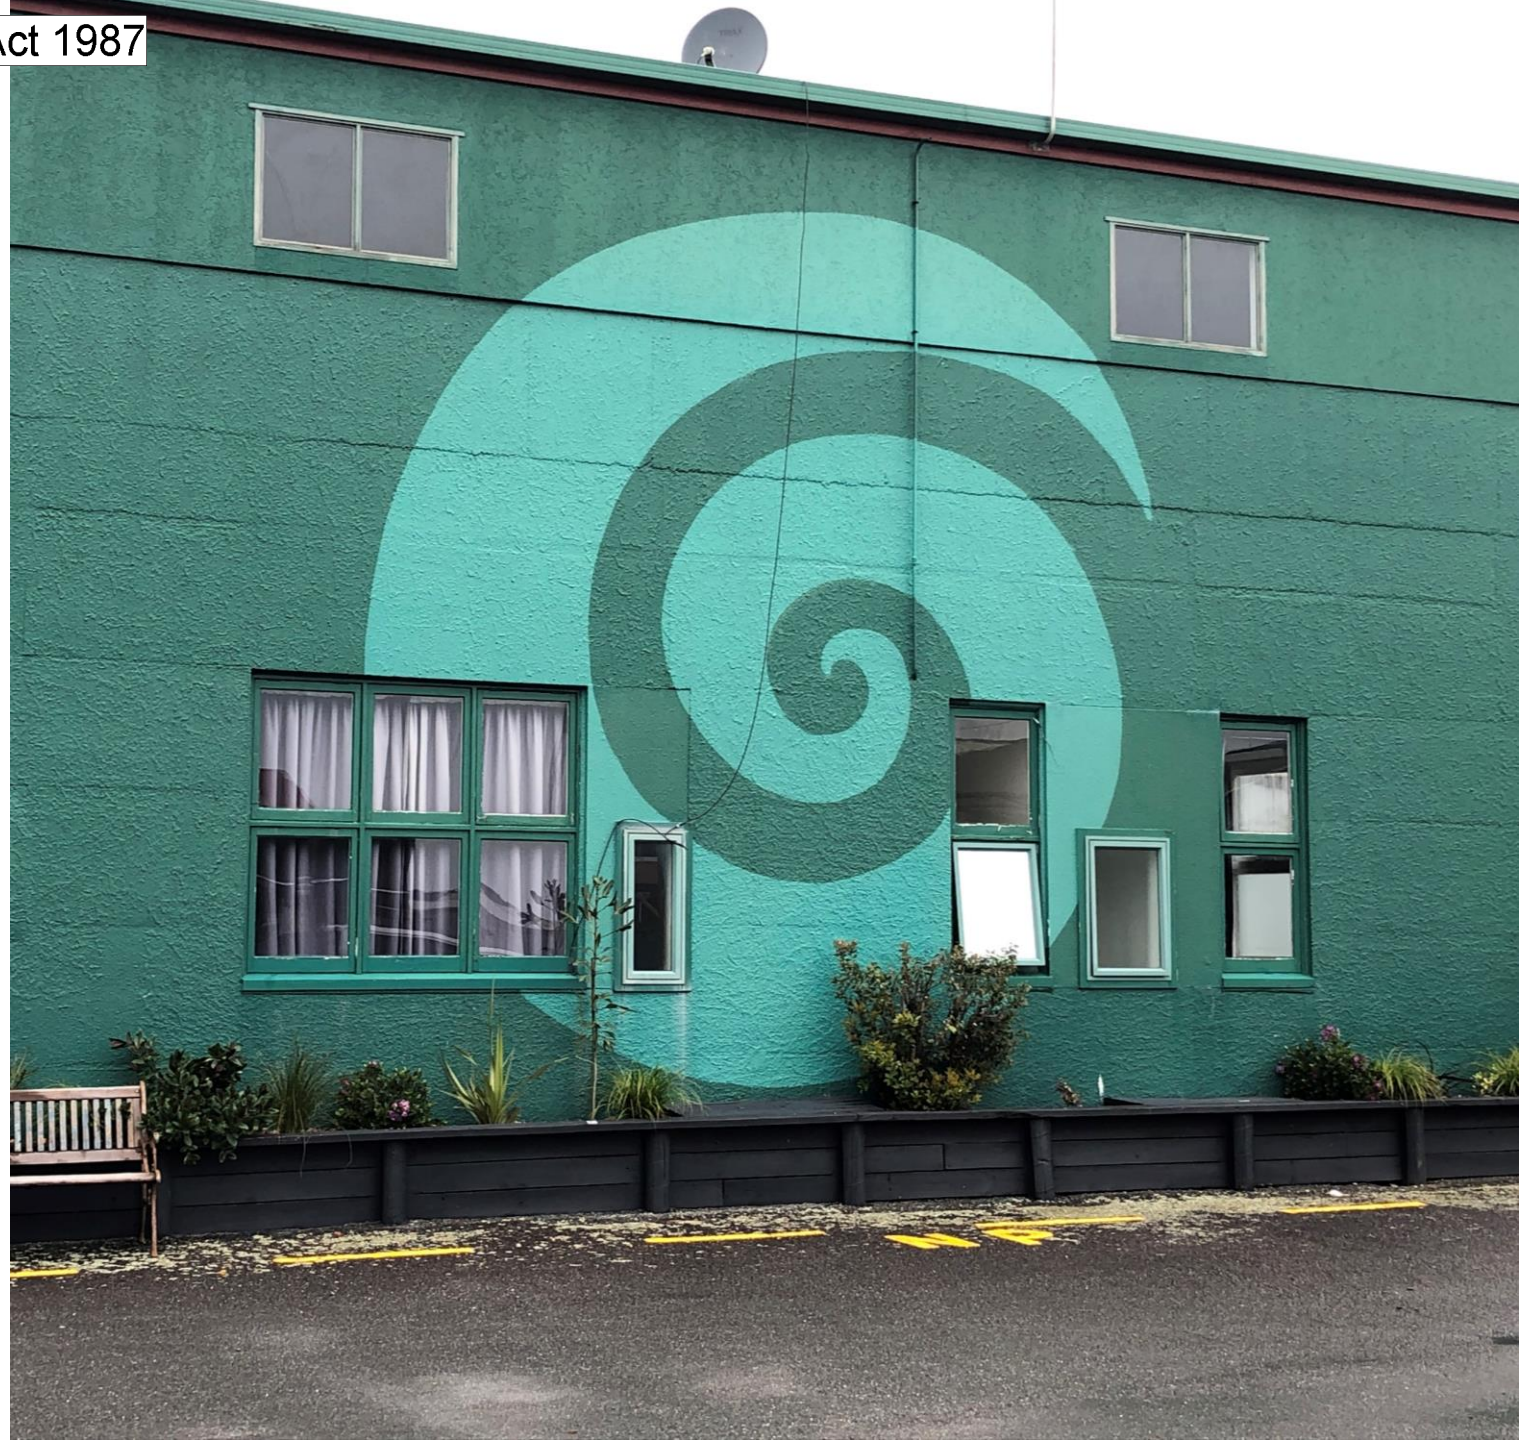
WEST FACING WALL

- The above photo highlights the West facing wall. This will need to be replastered and painted.
