Fairmaid Builders Ltd in conjunction with Jeff Evans Ltd

Mountain Jade Building General Report

Mountain Jade Building, Roof and outside cladding etc. General report

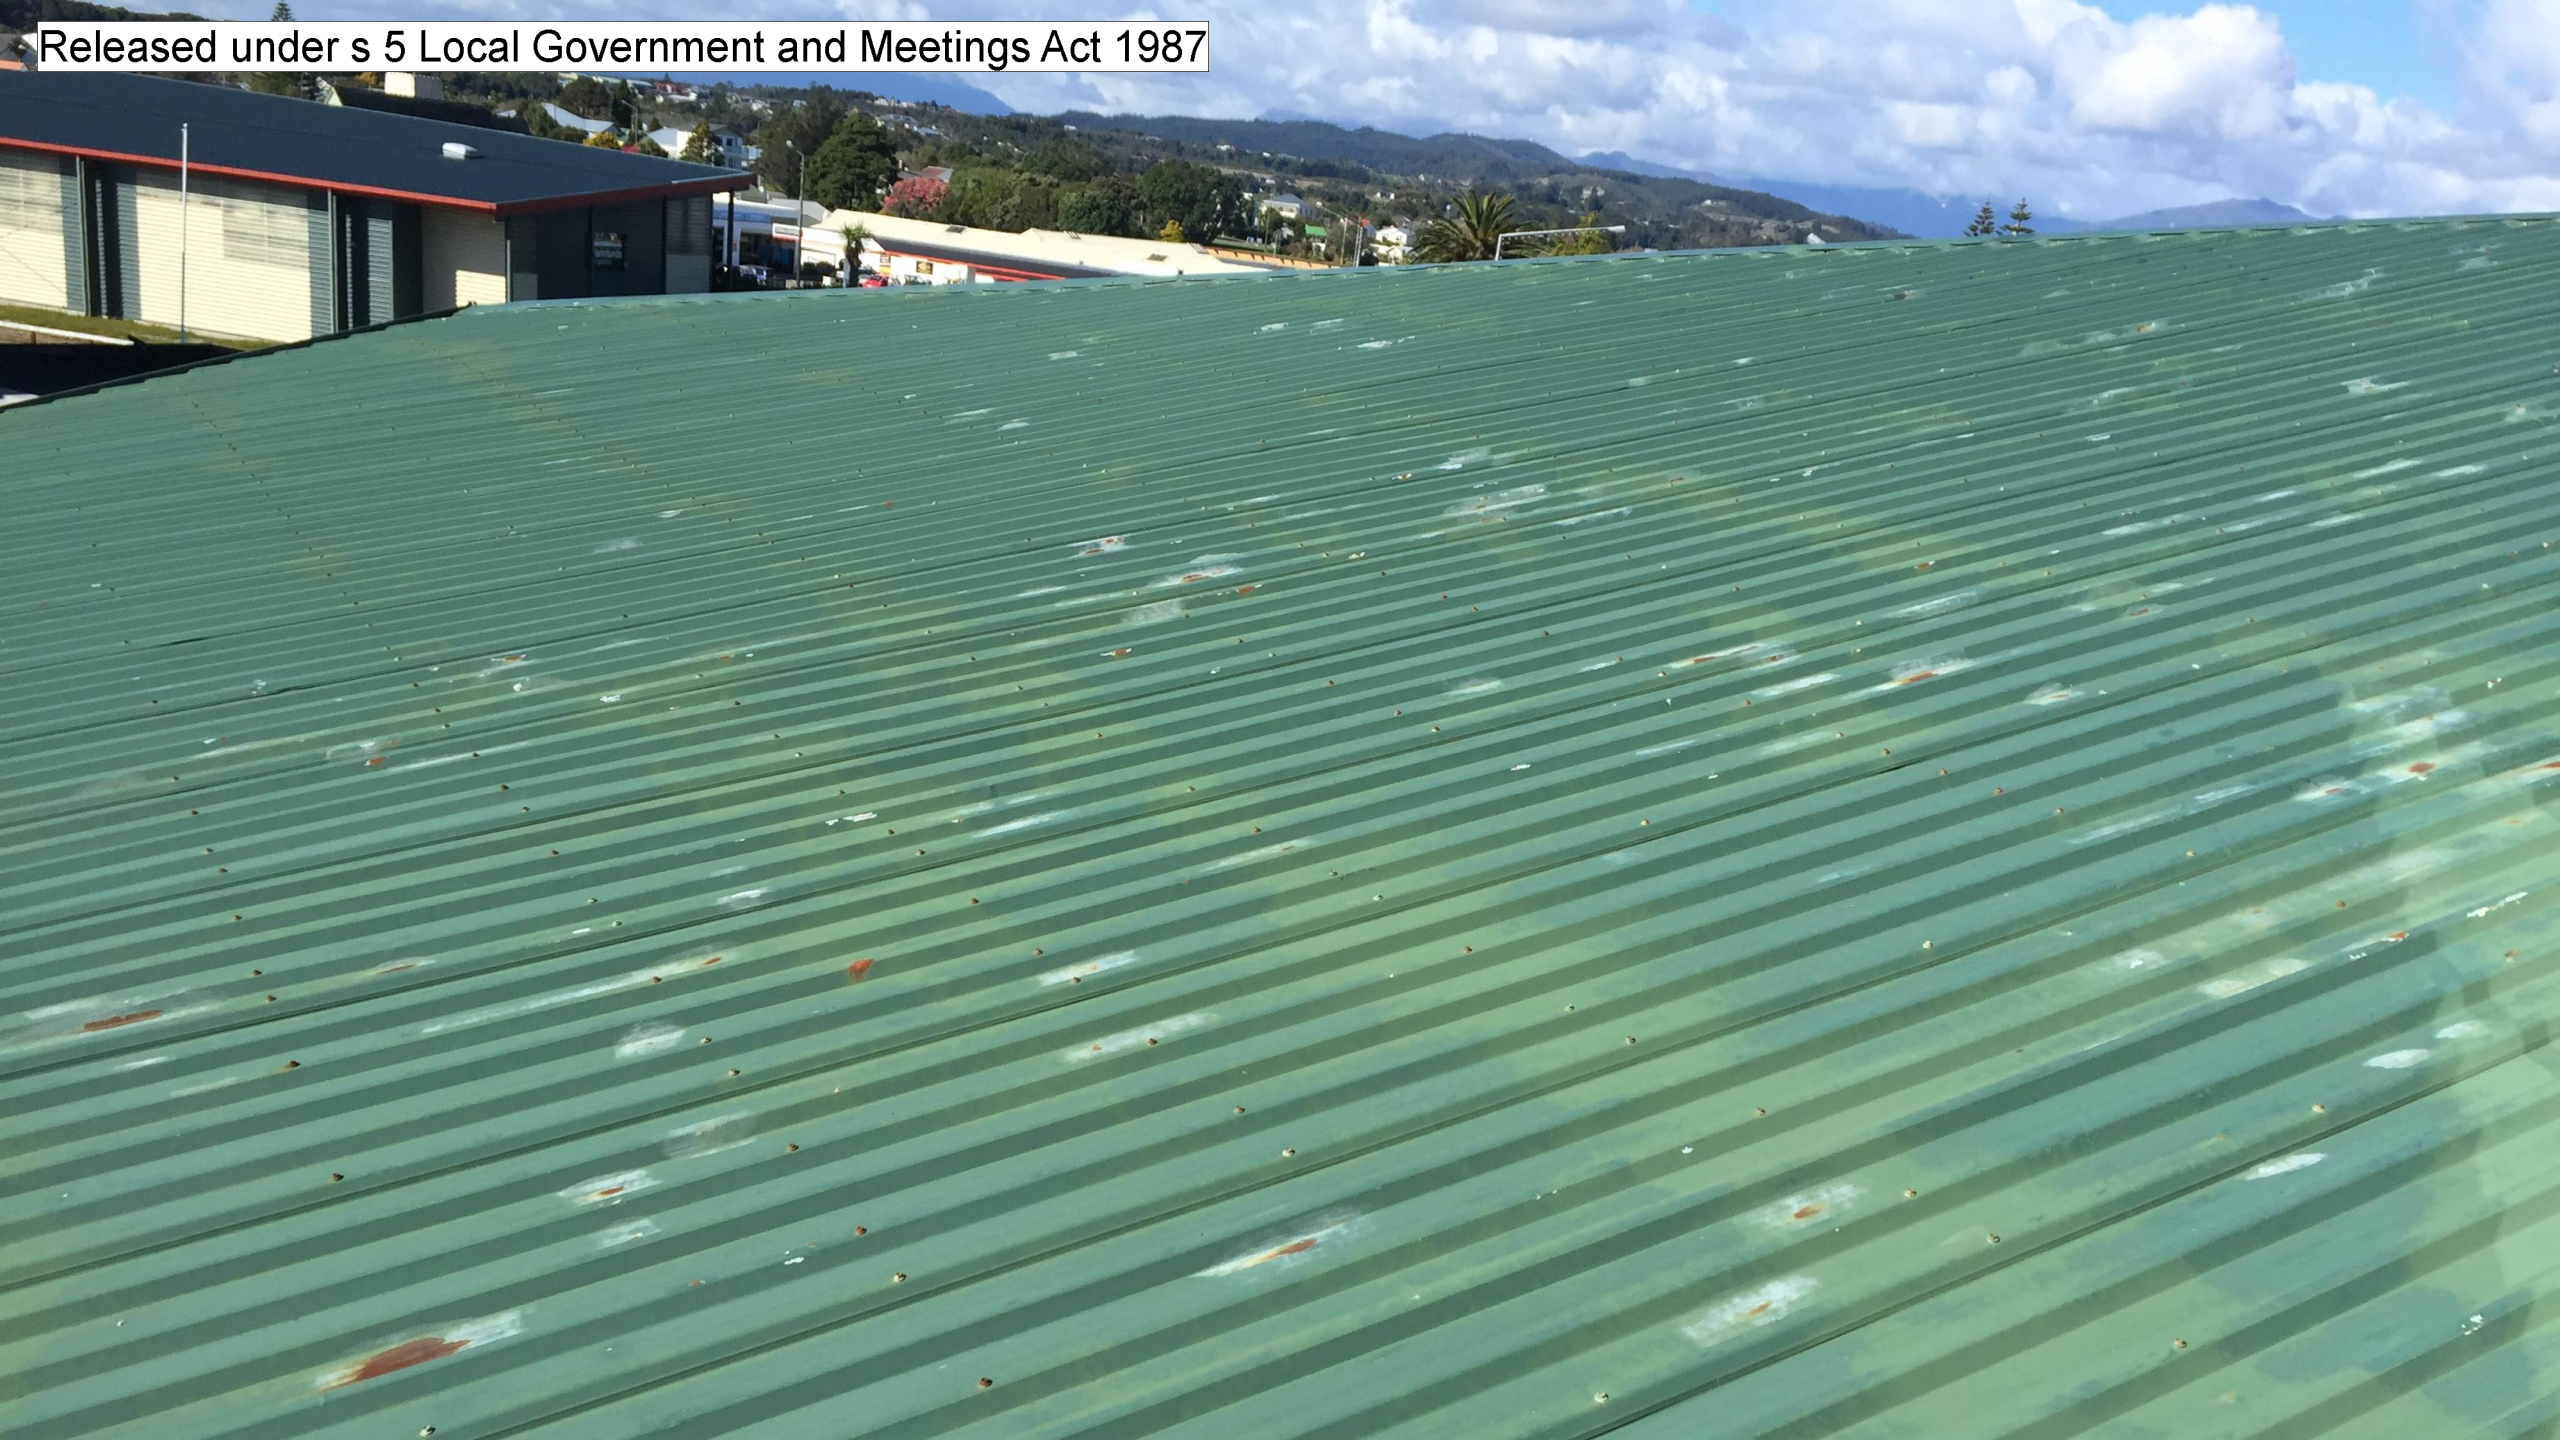
WALL FRAMES OVER EASTERN AREA

- We were unable to determine the condition of any wall framing but the lower area appeared okay. This is mainly concrete wall construction.
- Most of the windows appear to be in a reasonable condition, with not too many leaks.
- There are a few areas that will probably in time need addressing.
- Some cladding around the windows seem to not be in the best condition, although for a building cladded with a product like this (I presume it is a harditex) it is in good condition.
- The cladding does appear to be in a condition which shows no appearance of failing, but the plaster finish in areas could do with reinstating.

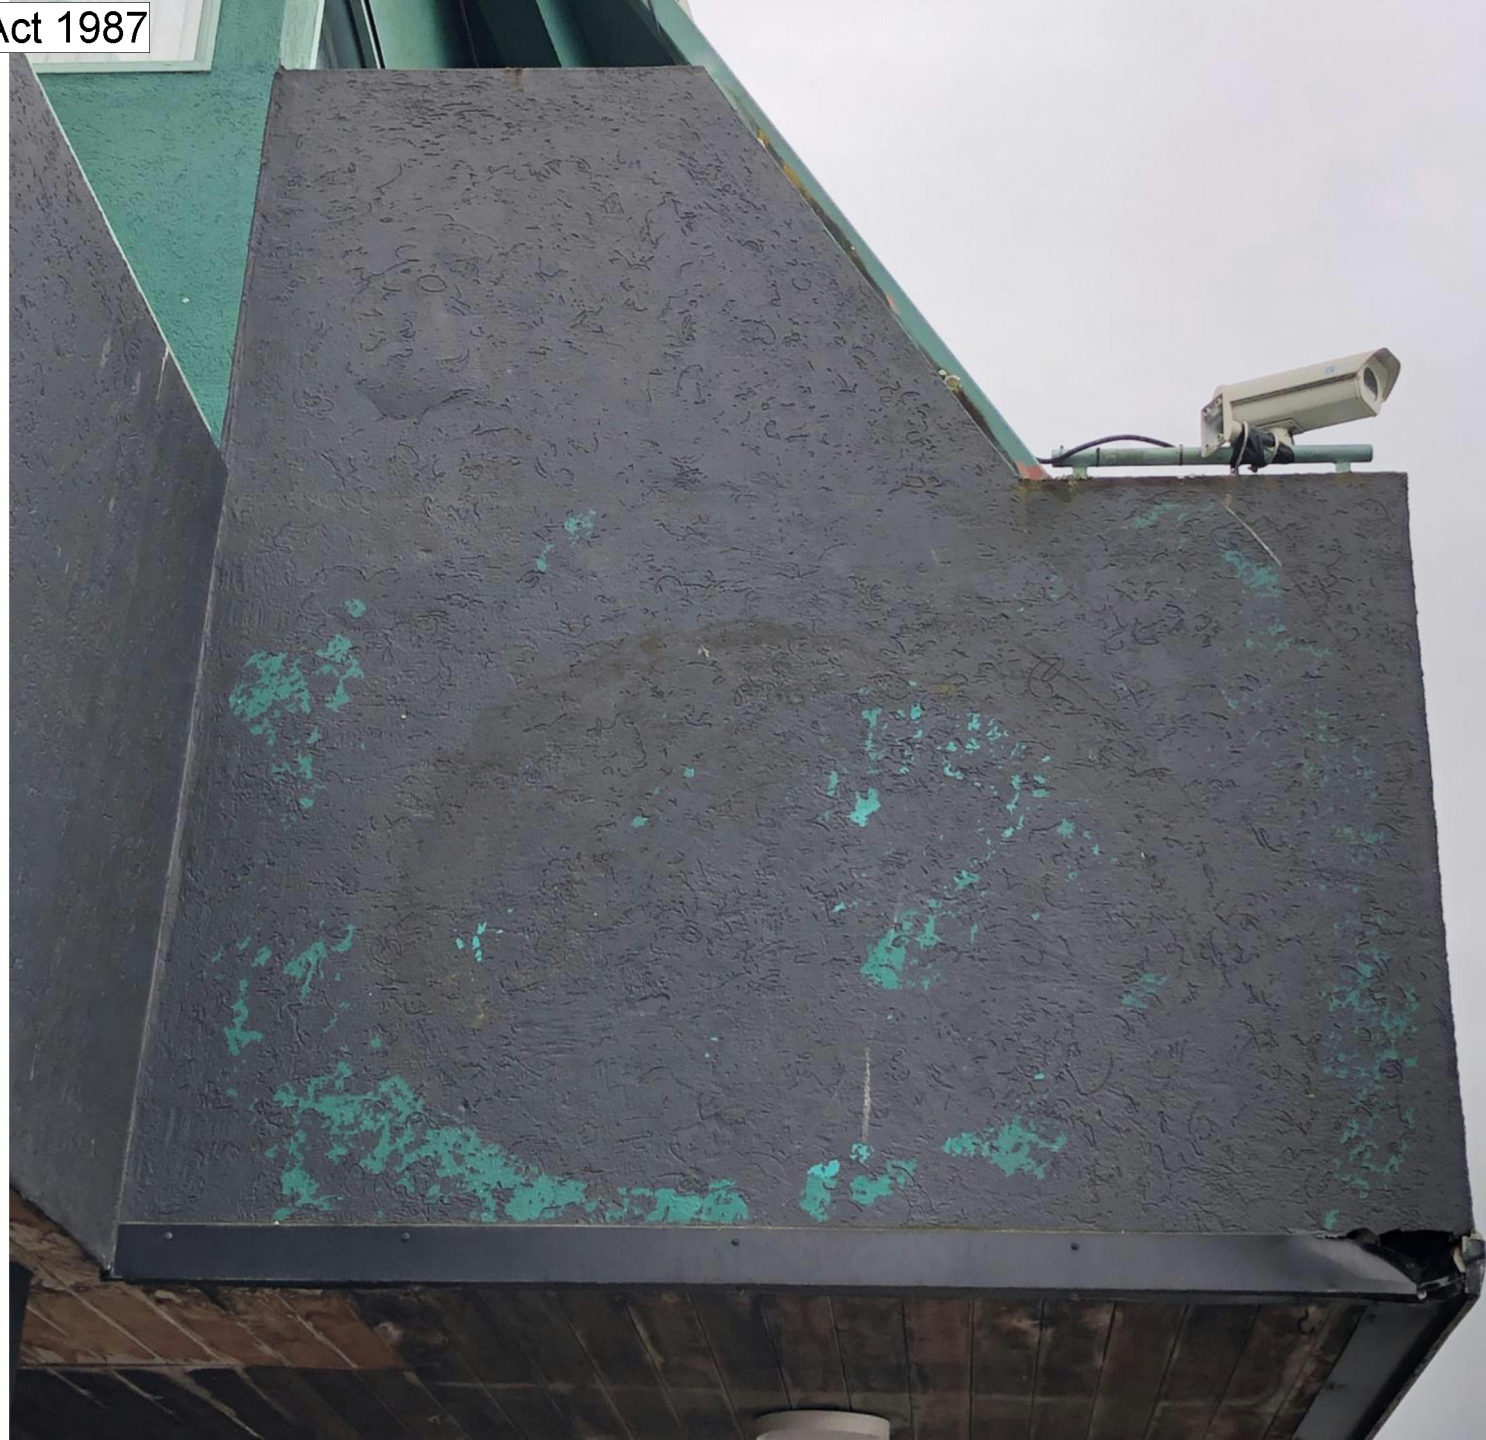
SOUTH EAST WALL OVER-LOOKING CARPARK

- There are at least three areas that will in my opinion need to be replaced, one is a back wall at right angles to the back car park this area which doesn't get any sun so the cladding over time has deteriorated and the plaster coating is coming away from the base material, this area would need to be reclad and a new cladding put on, my thought is Monotek sheet over a cavity system and then replastered and painted. It is worthy to note that considering the age of the cladding it is in very good condition.

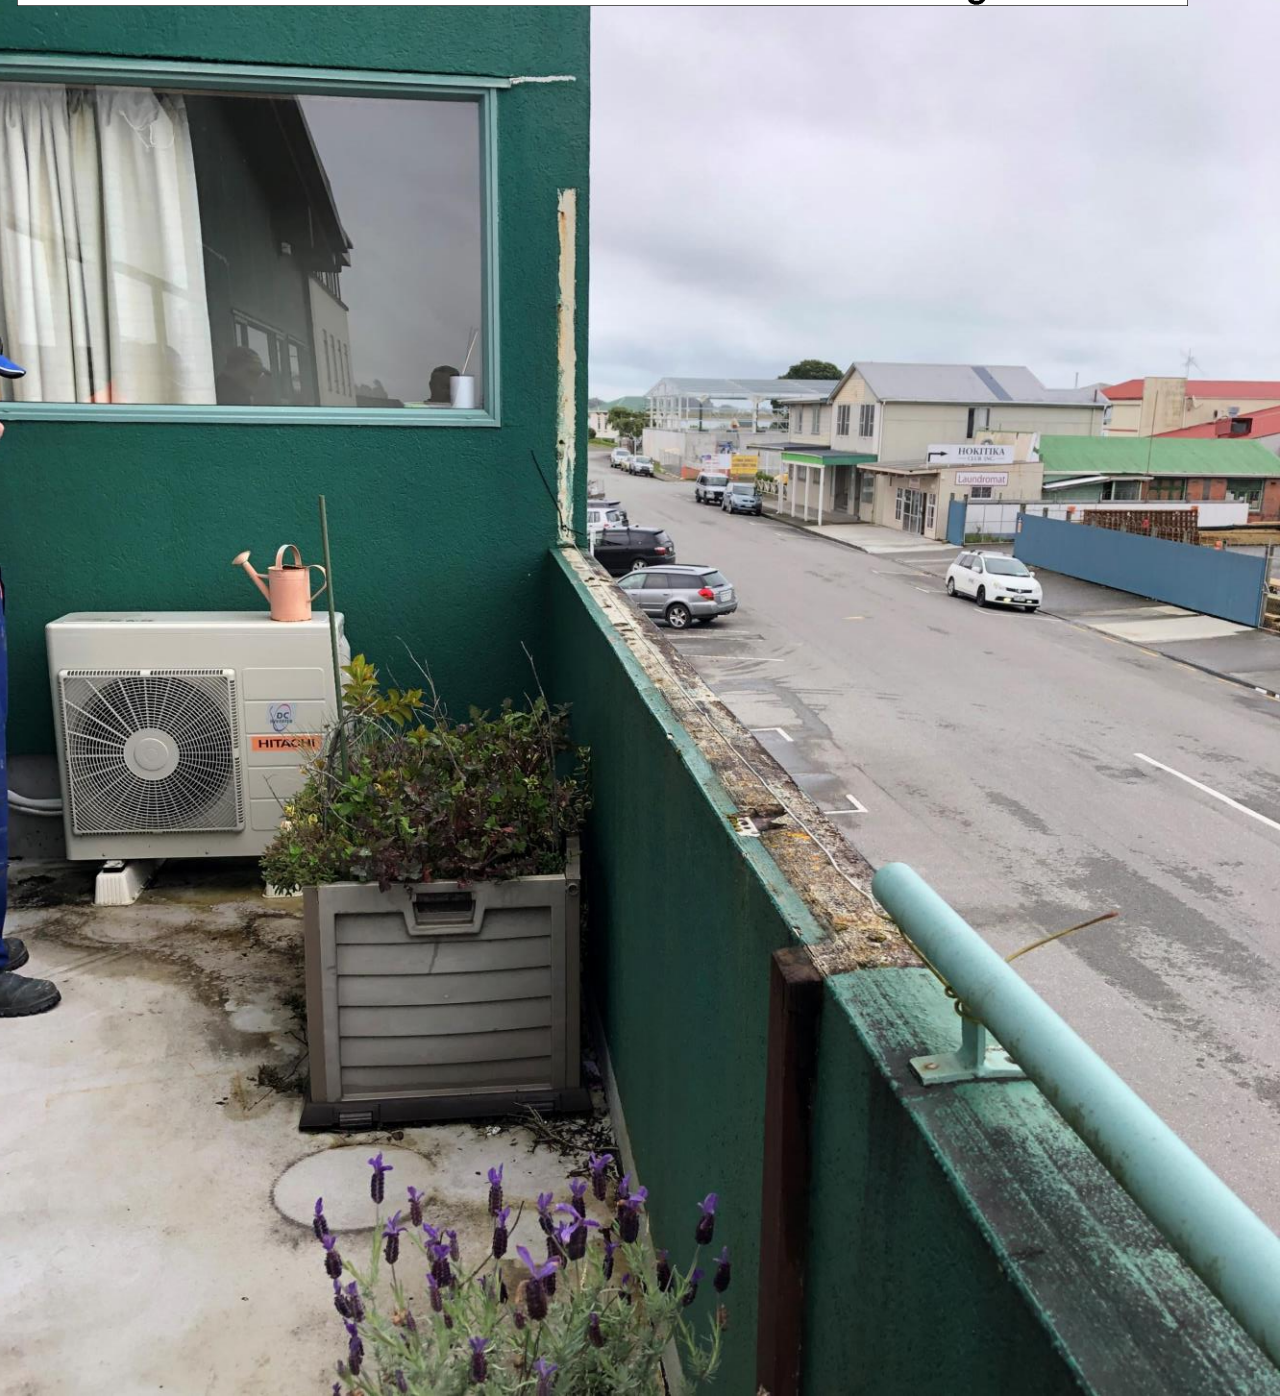
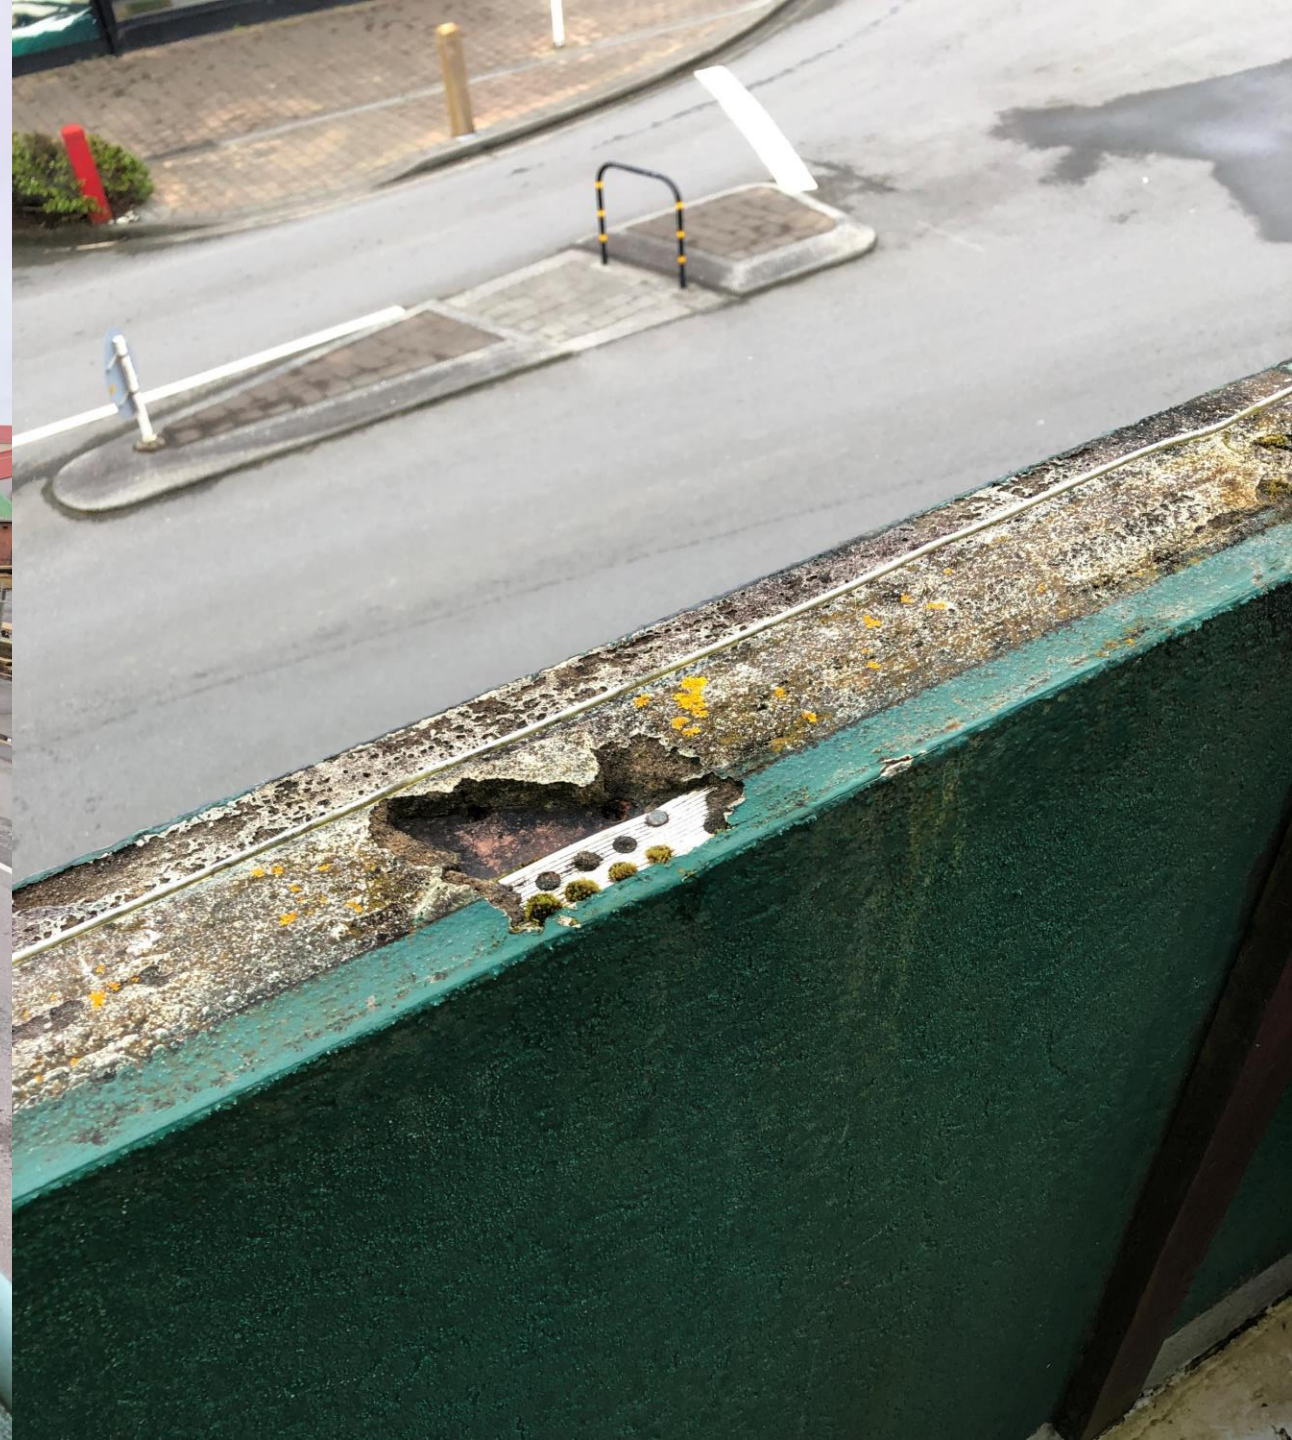
- Another area is the wall above the deck over Sewell Street and also the balustrade which would appear to have a water penetration problem, while there are other balustrade areas this would appear to be the only one with issues but an invasive check may prove otherwise, the wall in this area has obvious signs of deterioration and would need rebuilding, again this could be achieved by once again using the flat sheet and cavity system and also replastering and painting.
- These observations are taken without being able to view inside the wall but I have made an allowance for the replacement of some of the timber framing but not all of it.
